OUR REF.NO. 061

M645 SUPER

3 ROLL FILM HOLDER

7 TECHNICAL BULLETIN

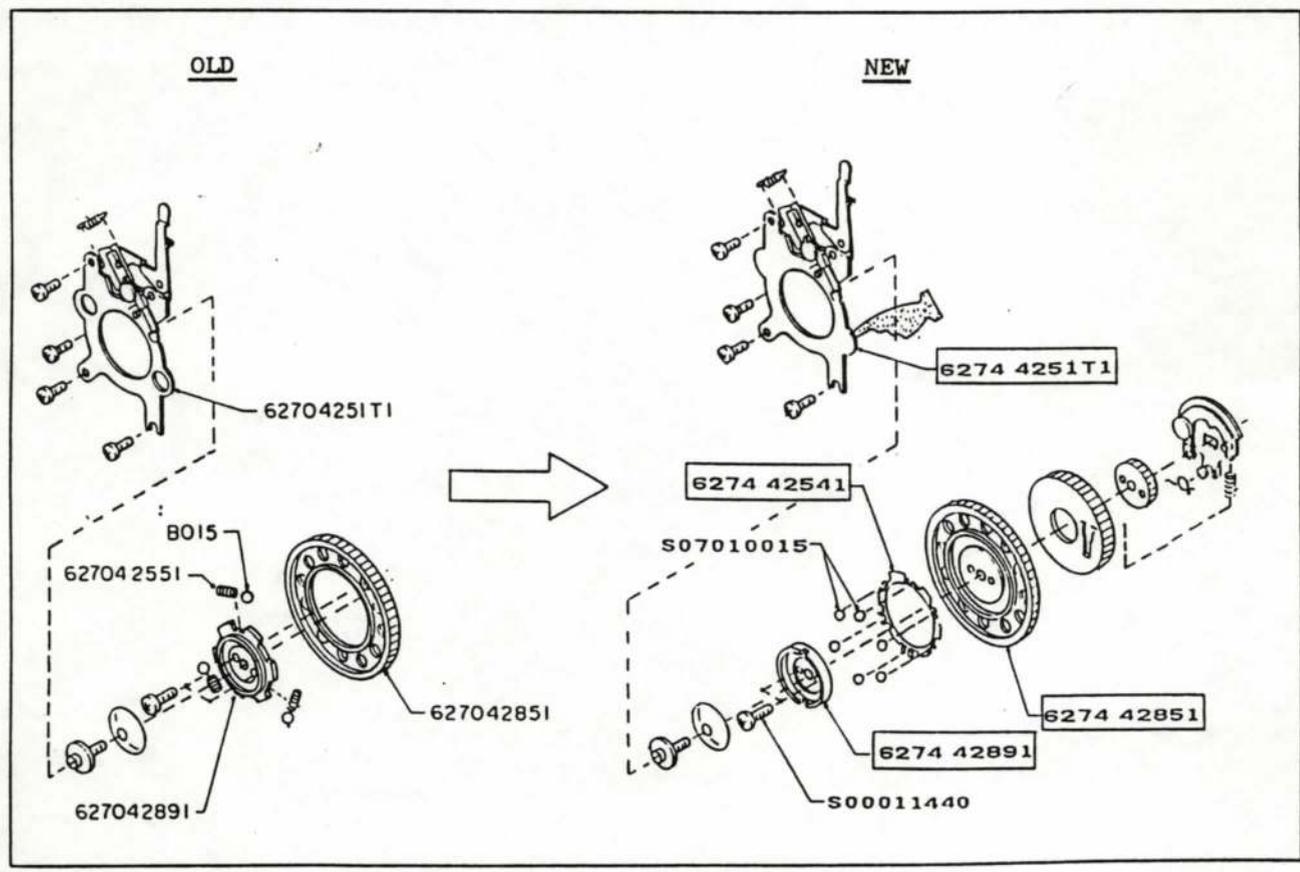
As informed you of the dropping out of steel ball(B01.5) for M645Super RFH with technical bulletin OUR REF.NO 057 of 25, DEC, 1987, Modify the winding mechanism to that of type 135 RFH.

<u>Disuse</u>		<u>Newly add.</u>
6270 4251T1	➔	6274 4251T1
6270 42891		6274 42891
6270 42851		6274 42851
6270 42551		6274 42541
BO 1.5 x 3pce		S07010015(BO 1.5) x 6pce

By modification No. "06" on backside of the Back lid for RFH.

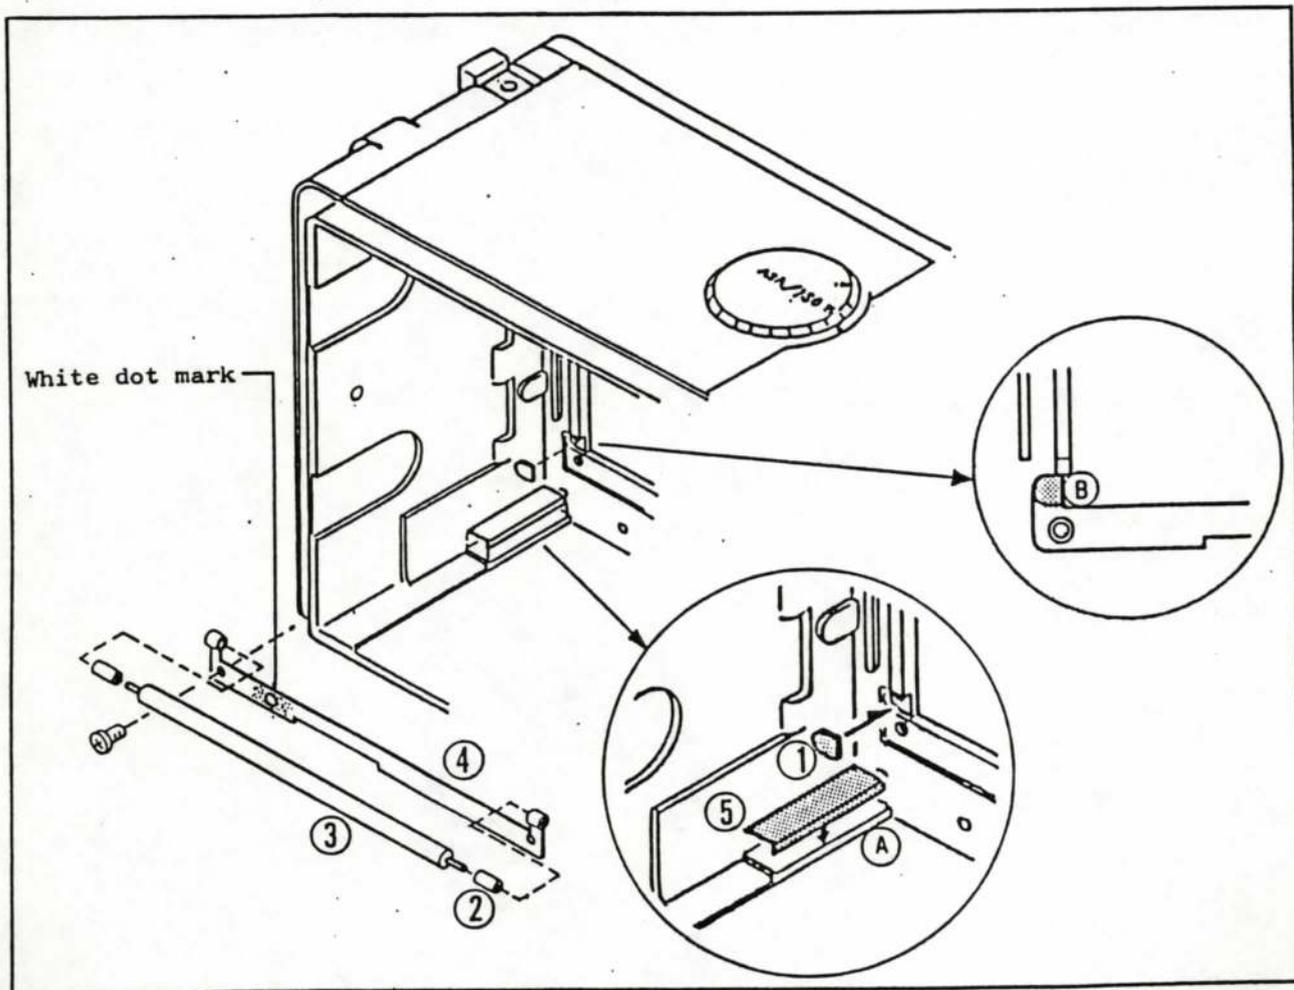
To make more smooth and light film winding two film rollers and two film guide plates should be provided for the improvement.

Note: This improvement will be very effective for film transport problem and film scratch on T-Max 120 film.

1. Improvement Parts:

- 1) Remove two film rollers and leaf spring of the roller.
- 2) Stick 6270 41391 washer into four cavities under brackets of the leaf spring with some adhesive (See B).
- 3) Set 2 new collar to both sides of 3 new roller and then set the roller into 4 leaf spring.
- 4) Install the leaf spring with roller to RFH with screws.
- 5) Stick 6270 41561 new film guide plate with some adhesive (pattex) on the place A additionally.

- * It is not necessary to remove the former film guide plate.
The new film guide plate must put on the former film guide plate.

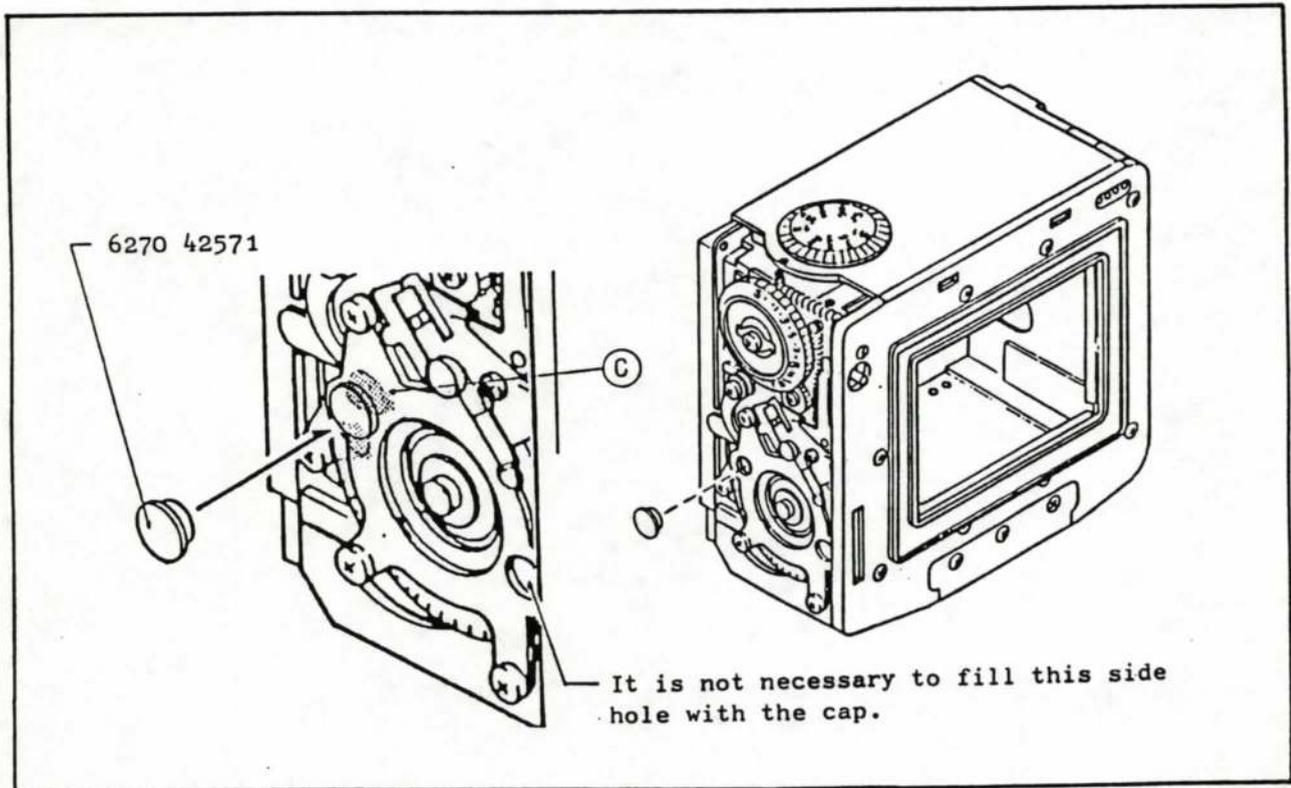
To prevent unexpected dropping out of B01.5 steel ball, the hole should be filled as follows :

- 1) Put 6270 42571 cap on the hole pointed with an arrow.
- 2) Sparingly apply a bit of adhesive (pattex) to the cap as shown in the drawing (C) .

Note : Don't put the cap on the other side hole.

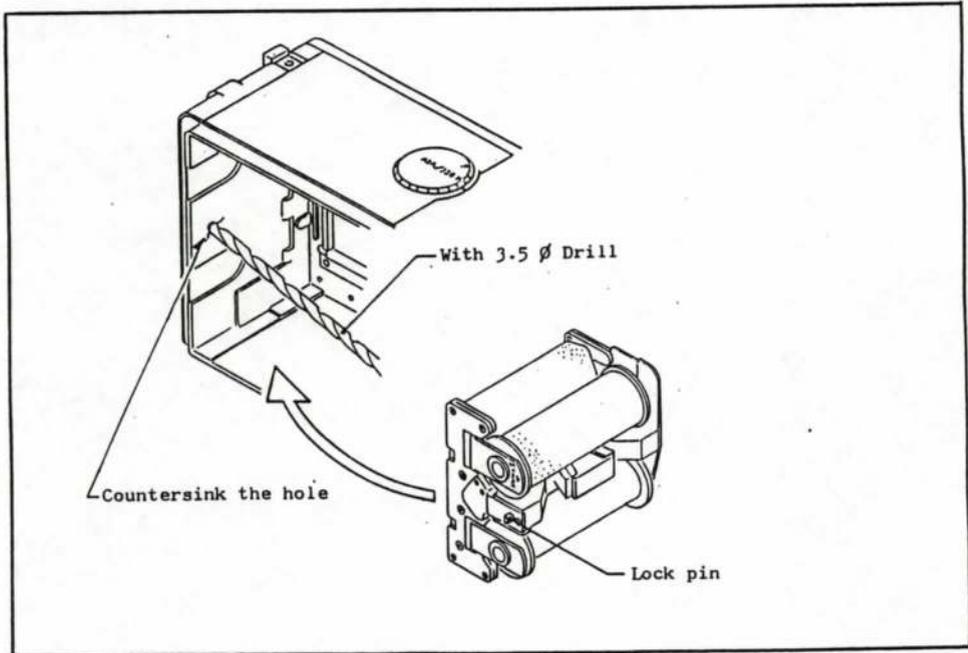
Phenomenon : When film insert is set into film roll holder, sometimes the lock pins of film insert will not be locked into the Hole of roll film holder certainly.

Step : Slightly countersink the hole of film roll holder shown in the drawing with 3.5 ϕ drill.

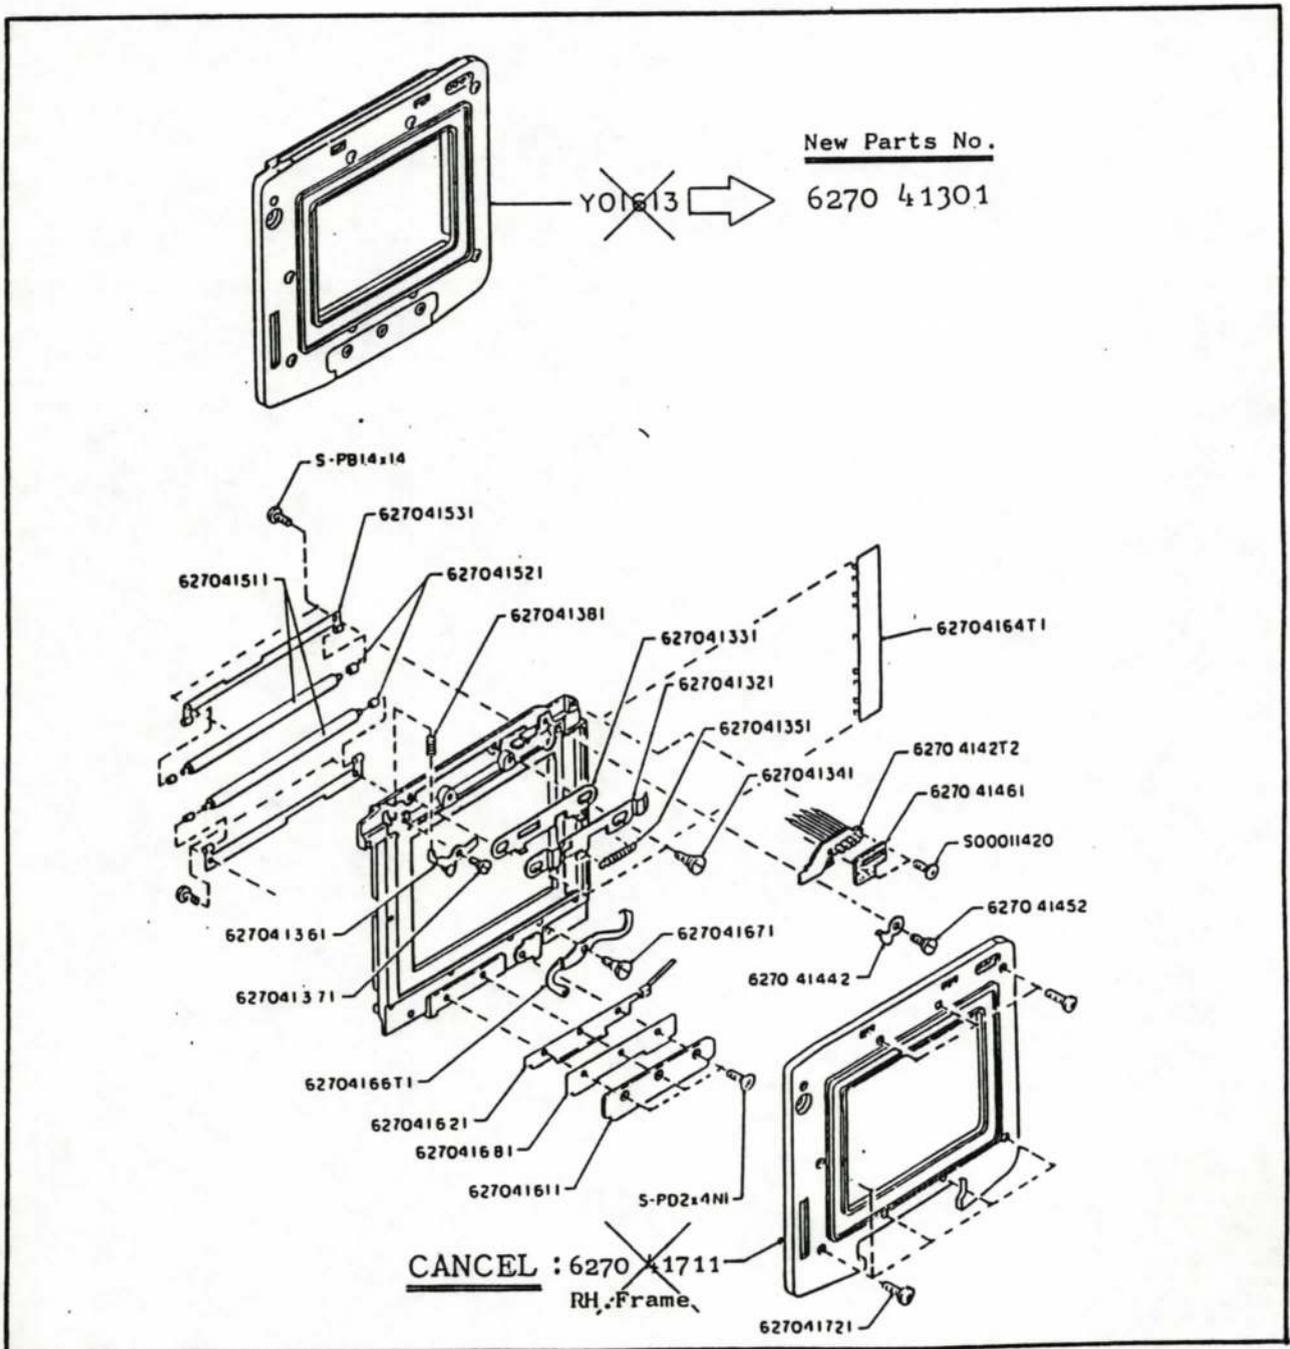
Will be not supplied P/NO 6270 41711 : RH Frame.

F.Holder to preserve accuracy of the flange back and film rail surface flatness, so that replacement of RH.frame is assembled into F.Holder body.

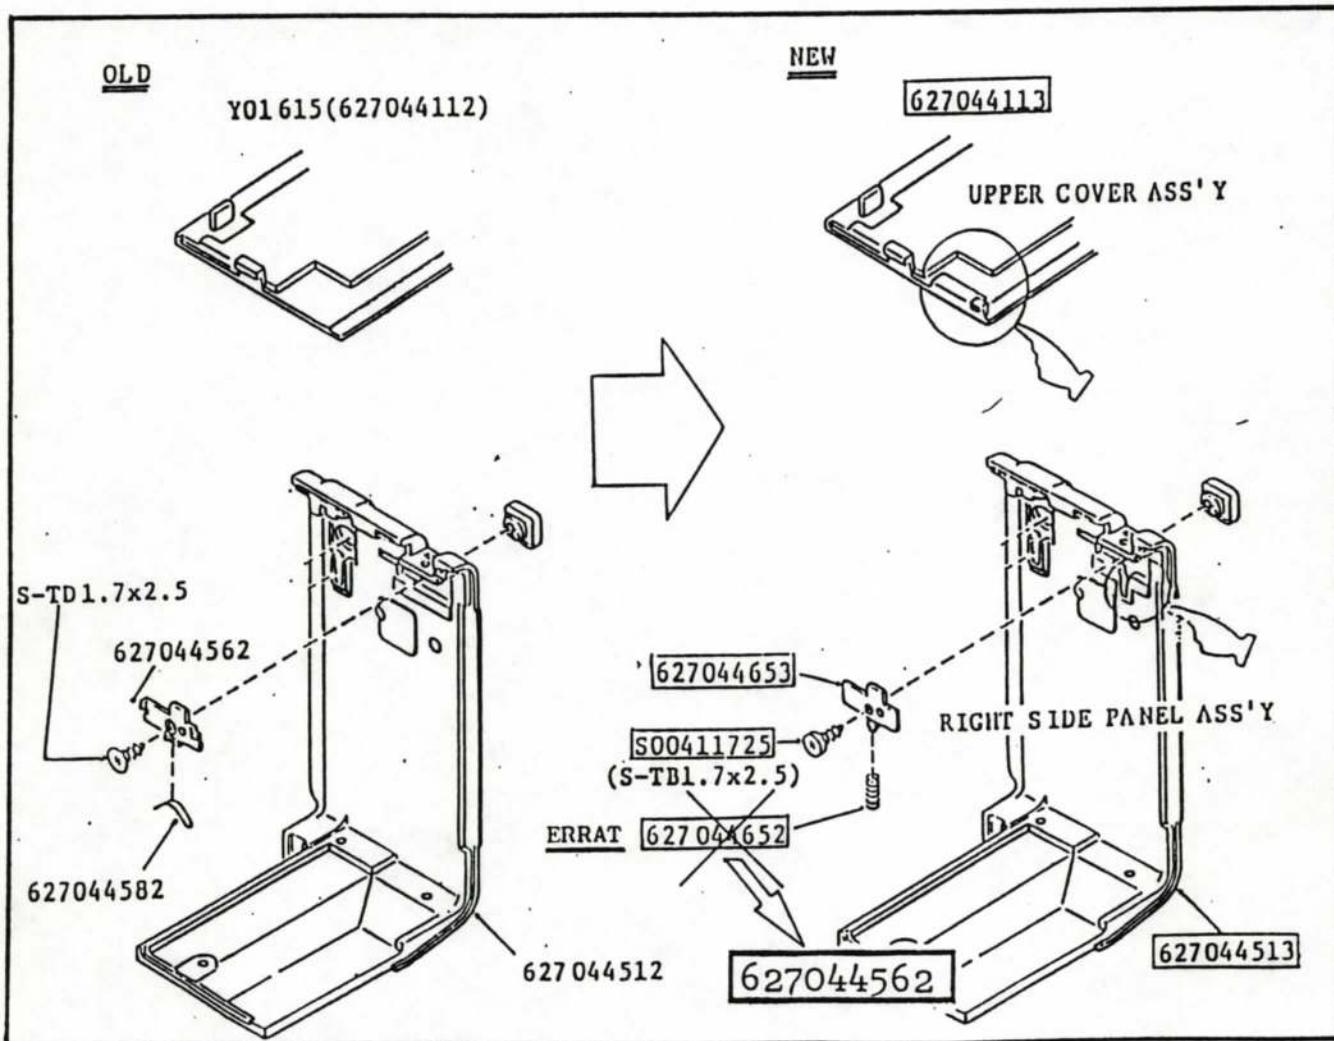
1. PURPOSE : Improvement of lock release system.

2. REPLACEMENT OLD & NEW PARTS

: New upper cover and new side panel must be in set:

: Compatibility of new and old.....None

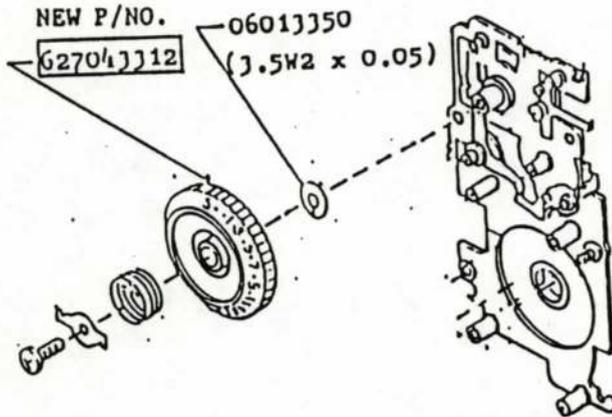
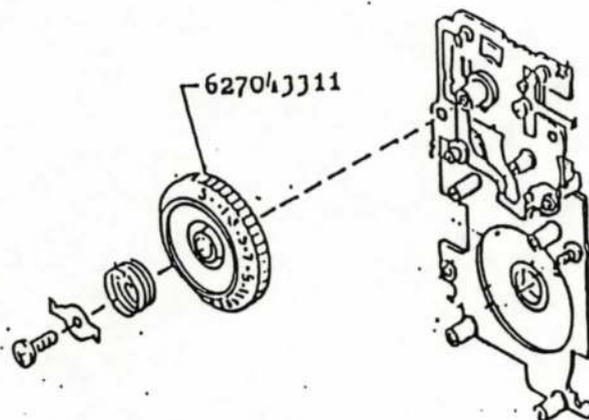
1. CAUSE

: Gear teeth of the E-Counter Disk are Broken.

2. MODIFICATION

: Material of E-Counter Disk : CHANGED. (Special hard material)

: Apply a Washer.

3. REPAIR STEP

: Replacement of E-Counter Disk and Putting of the Washer.

NEW P/NO.627043312 E-COUNTER DISK.
P/NO.06013350(3.5W2x0.05) WASHER.

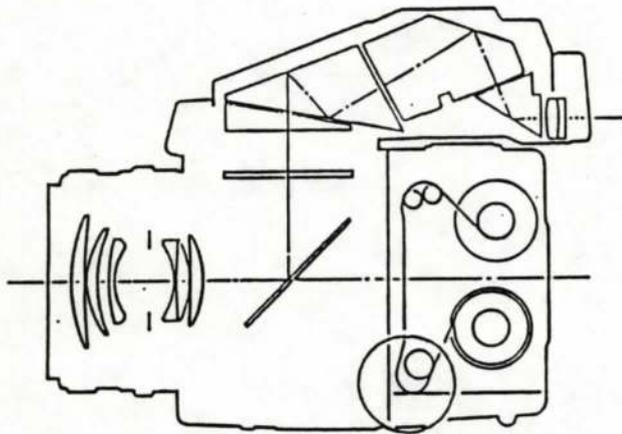
1. PHENOMENON

: Scratch on film surface at the 13th~15th exposure frame.

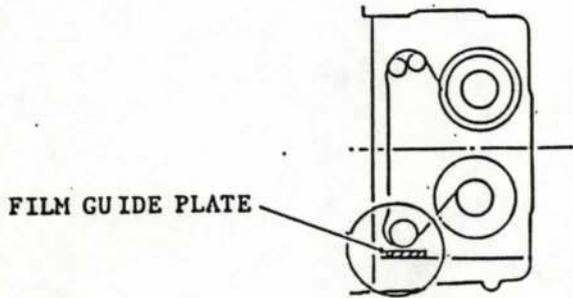
2. CAUSE

: Film surface will rub inner wall of film chamber at 13th to 14th exposure frame.

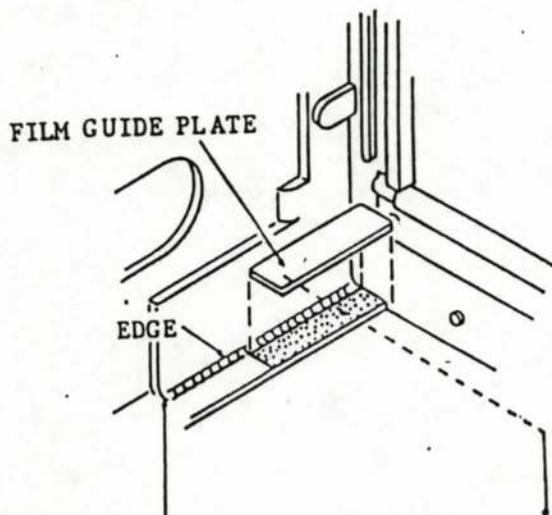
Don't put Film guide plate on body edge.
(Shade position)

3. REPAIR STEP

- : Apply the film guide plate to each corner
- : New parts No.627041571 Film guide plate.

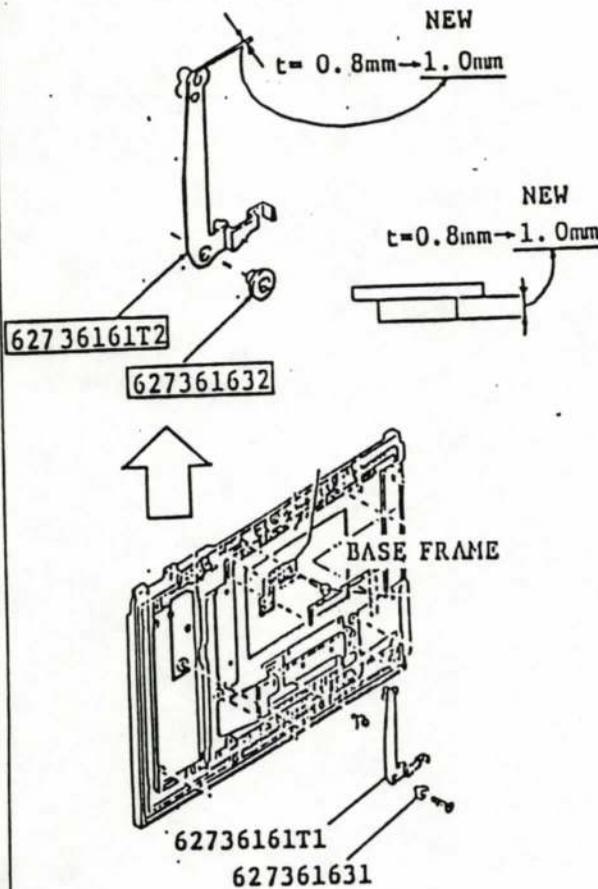
1. CAUSE

: Lock release lever : Weakened

2. MODIFICATION

: 62736161T2 Lock release lever
: 62736132 Collar
