M645 SUPER

7 TECHNICAL BULLETIN

| NEW S. BUTTON GUIDE | 1/1 | 76 | 10 |

OUR REF.NO. 060

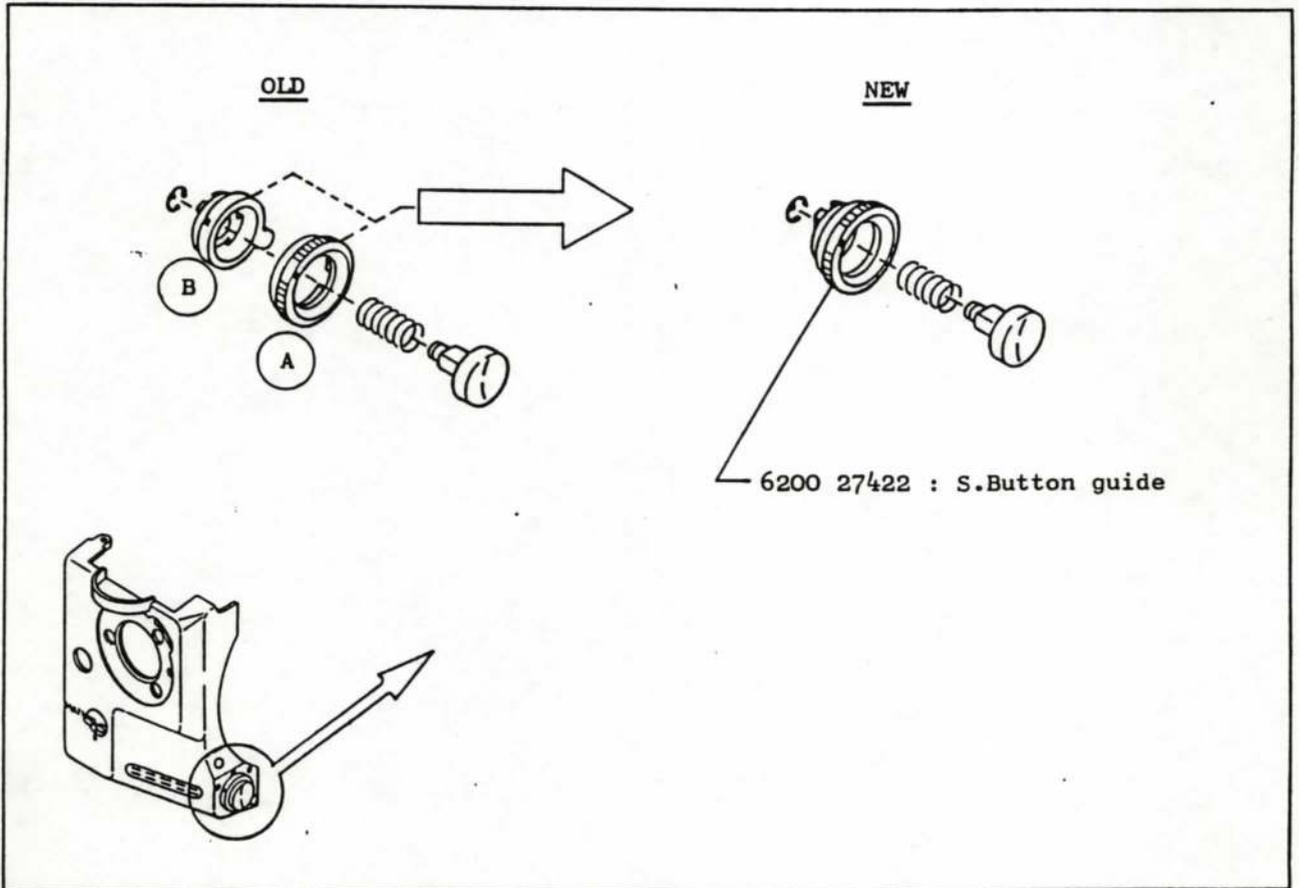
The (A) and (B) parts of the S.Button guide has been modified in a unit part to avoid dropping out of (A) parts.

Modification Date : Since 1987 October.

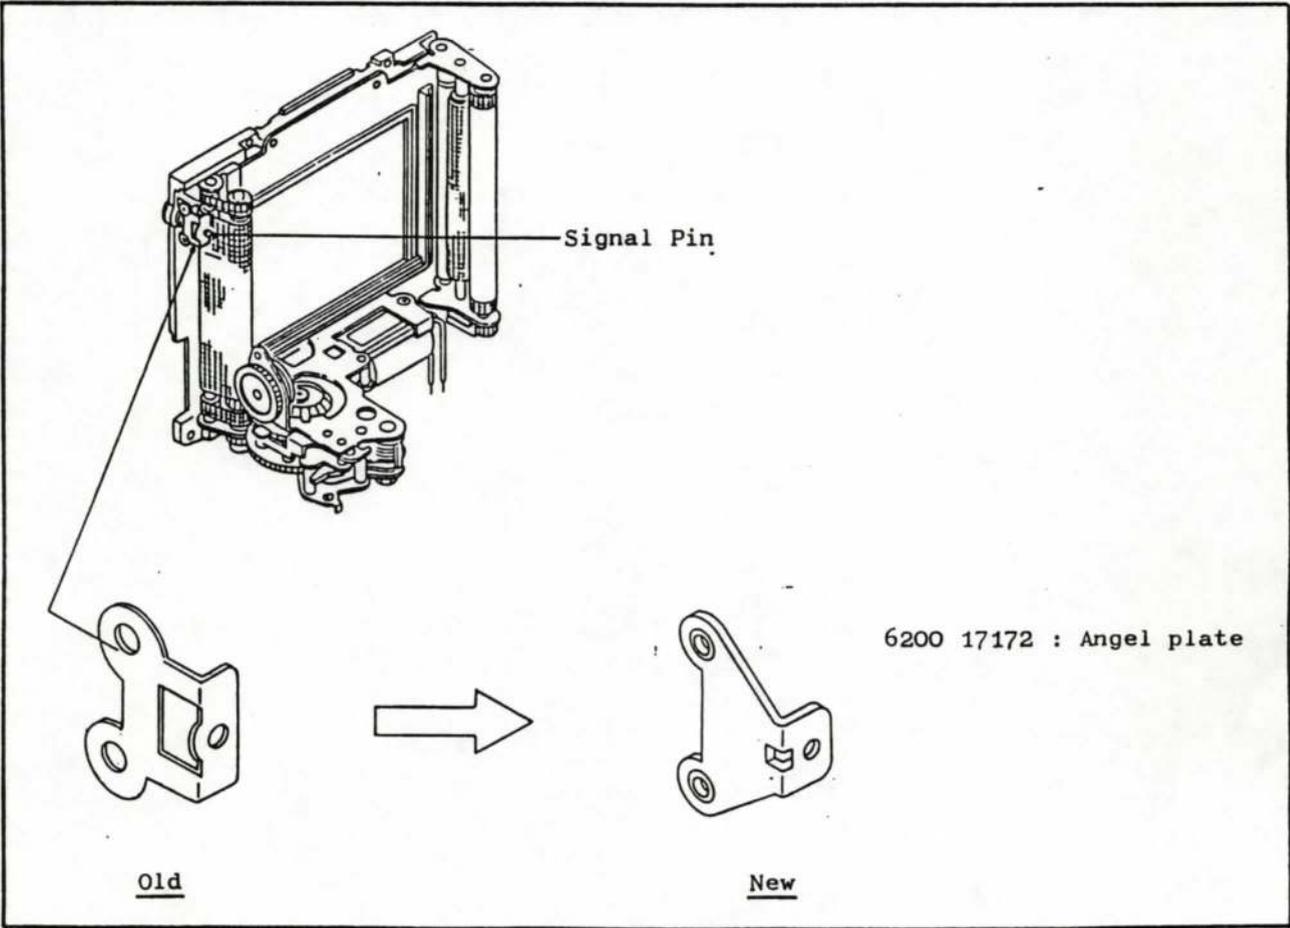
Phenomenon : Signal Pin do not operate properly.

Modification : Shape of Angel plate.

Modification Date : Since 1987 May Production.

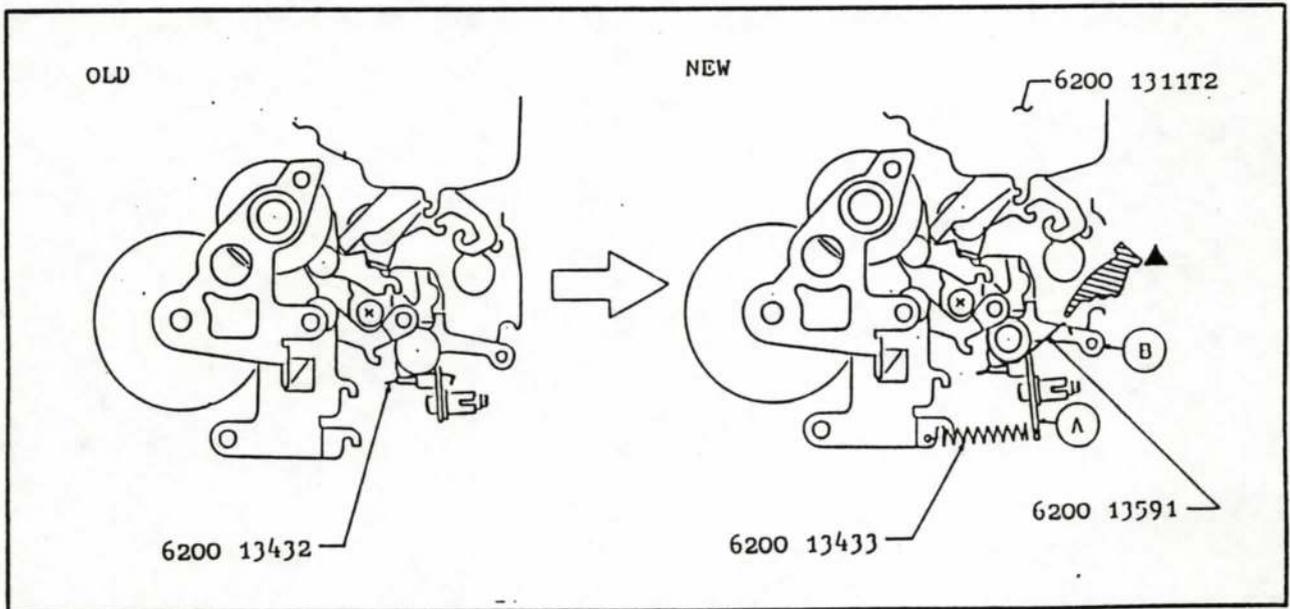
Phenomenon : When winding crank is wound, suddenly mirror is released and stays at upper position.

Cause : Lever A and B do not operate properly.

Modification : 1) An additional new spring : 6200 13432  
2) Change of spring shape and its fixing position.

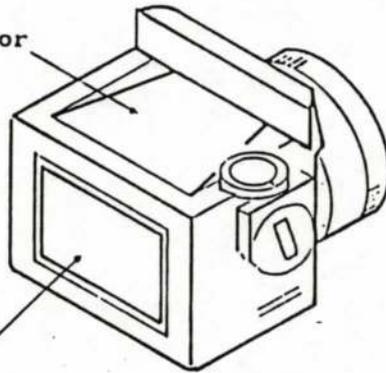
A When wound up, mirror does not return and stays at risen position.

Shutter curtain is kept open.

1) Improper adjustment of the mirror release lever.

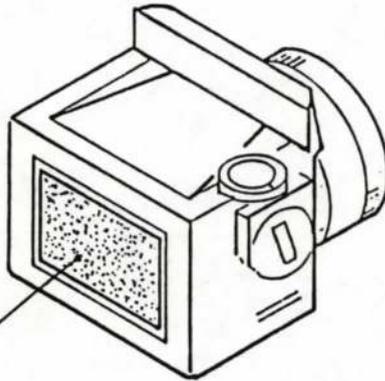
A' As same as above A

Shutter curtain (2nd) is closed.

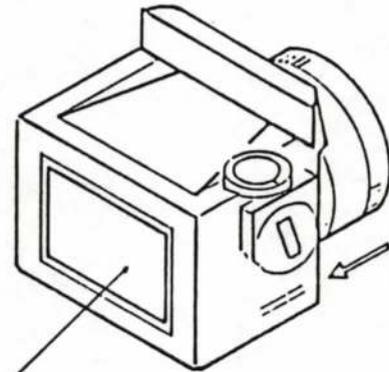
B After released, mirror does not return and stays risen position.

Shutter curtain is kept open.

- 1) Shutter curtain ribbon was teard off.
  - \* If the second shutter curtain of the mechanical shutter release does not function, the cause should be that the shutter curtain ribbon is off.
- 2) Dirty spring of the trigger switch and improper contact pressure. ( proper contact pressure : 30g)

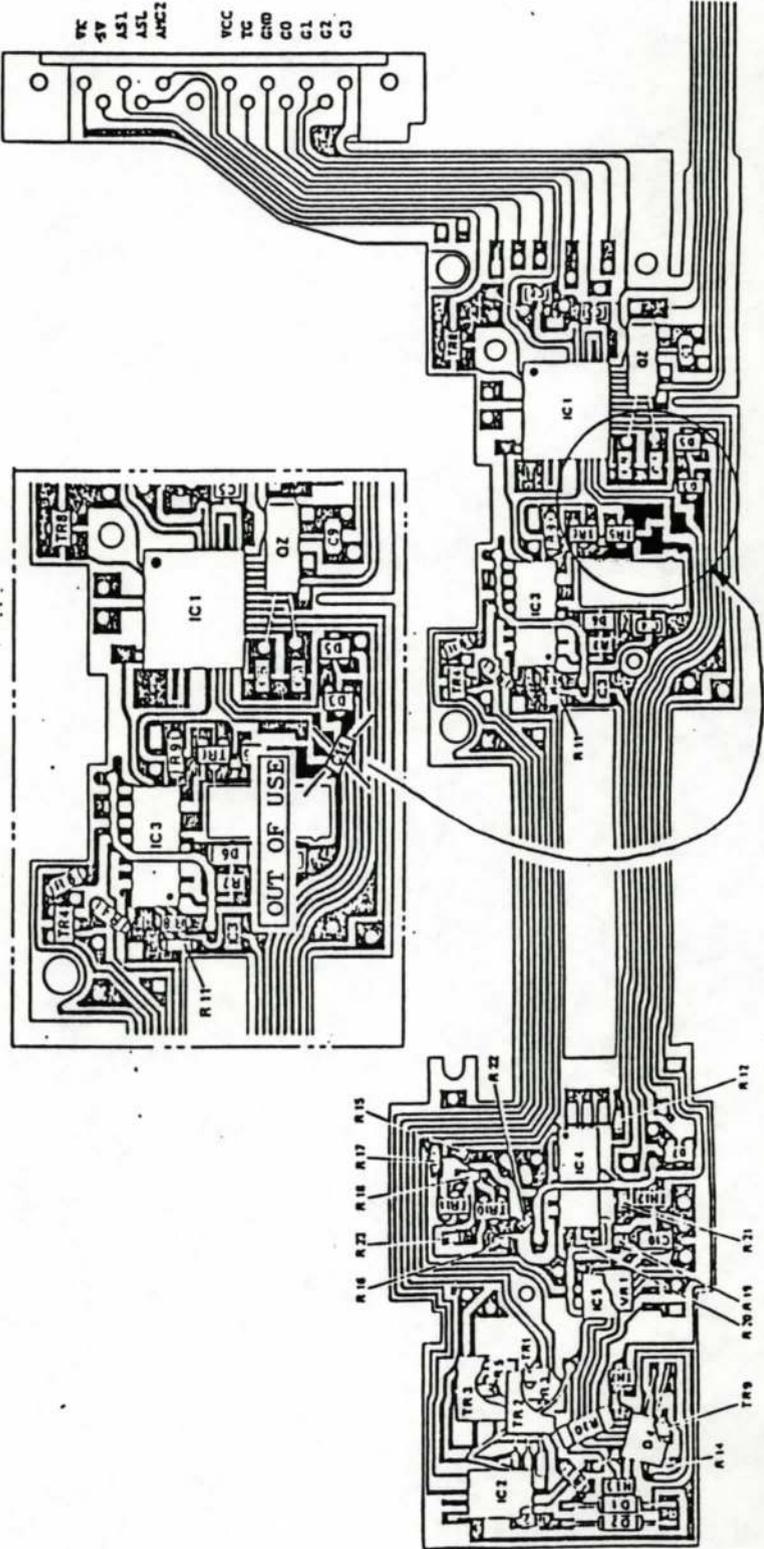
- 1. PHENOMENON : After completion of winding up with power drive, again move the selector lever of power drive to start position sometimes release shutter dose not work.
- 2. MODIFICATION : Take off C11(0.1μF 15v) condenser from Main F.P.C board.
- 3. MODIFICATION DATE : From May, 1986.

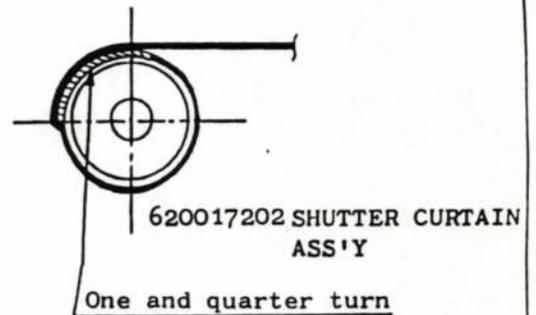
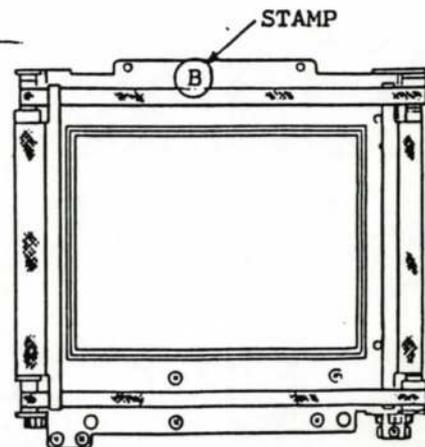
PHENOMENON : The curtain ribbon was teard off.

MODIFICATION : A longer curtain ribbon is used to increase the bonding area and adhesive strength.

Modification mark of shutter curtain : "B" stamp on the shutter base plate.

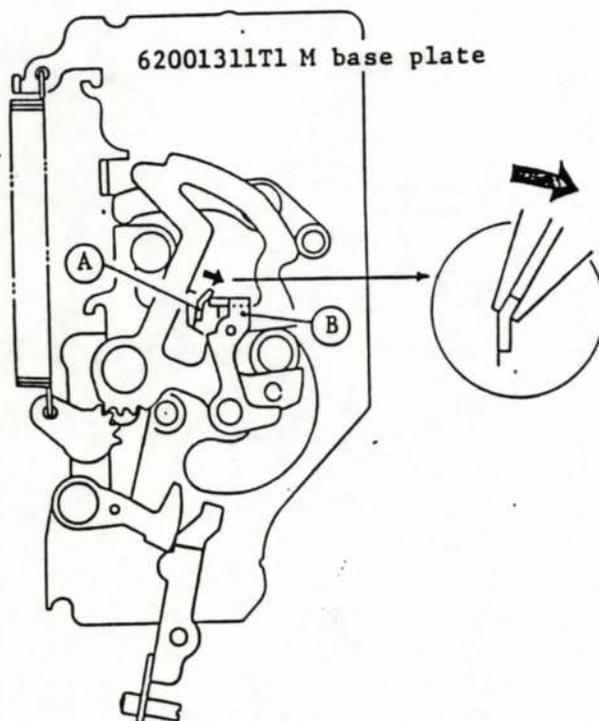
MIRROR NOT RETURN

: MIRROR does not return even if 2nd curtain closes completely.

- : (A) mirror release lever does not kick
- : (B) mirror-up lever properly

: Carefully bend the tip of (A) lever.

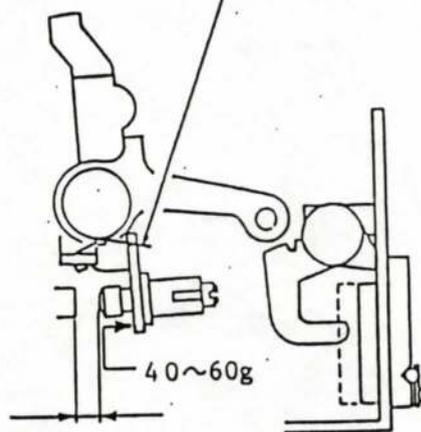
NEW 0.2~0.3mm

OLD 0.1~0.2mm

: The mirror does not return and stays at risen position.

: 2nd curtain does not run because 620013431 spring of S-lever does not work adequately.

: Shape of spring 620013431 → 620013432

: Replace the spring with new one.

Note) After replacement of the spring adjustment of shutter release lever is required by referring Repair manual page 40- (A).
