OUR REF.NO. 061

M645 SUPER

3 ROLL FILM HOLDER

7 TECHNICAL BULLETIN

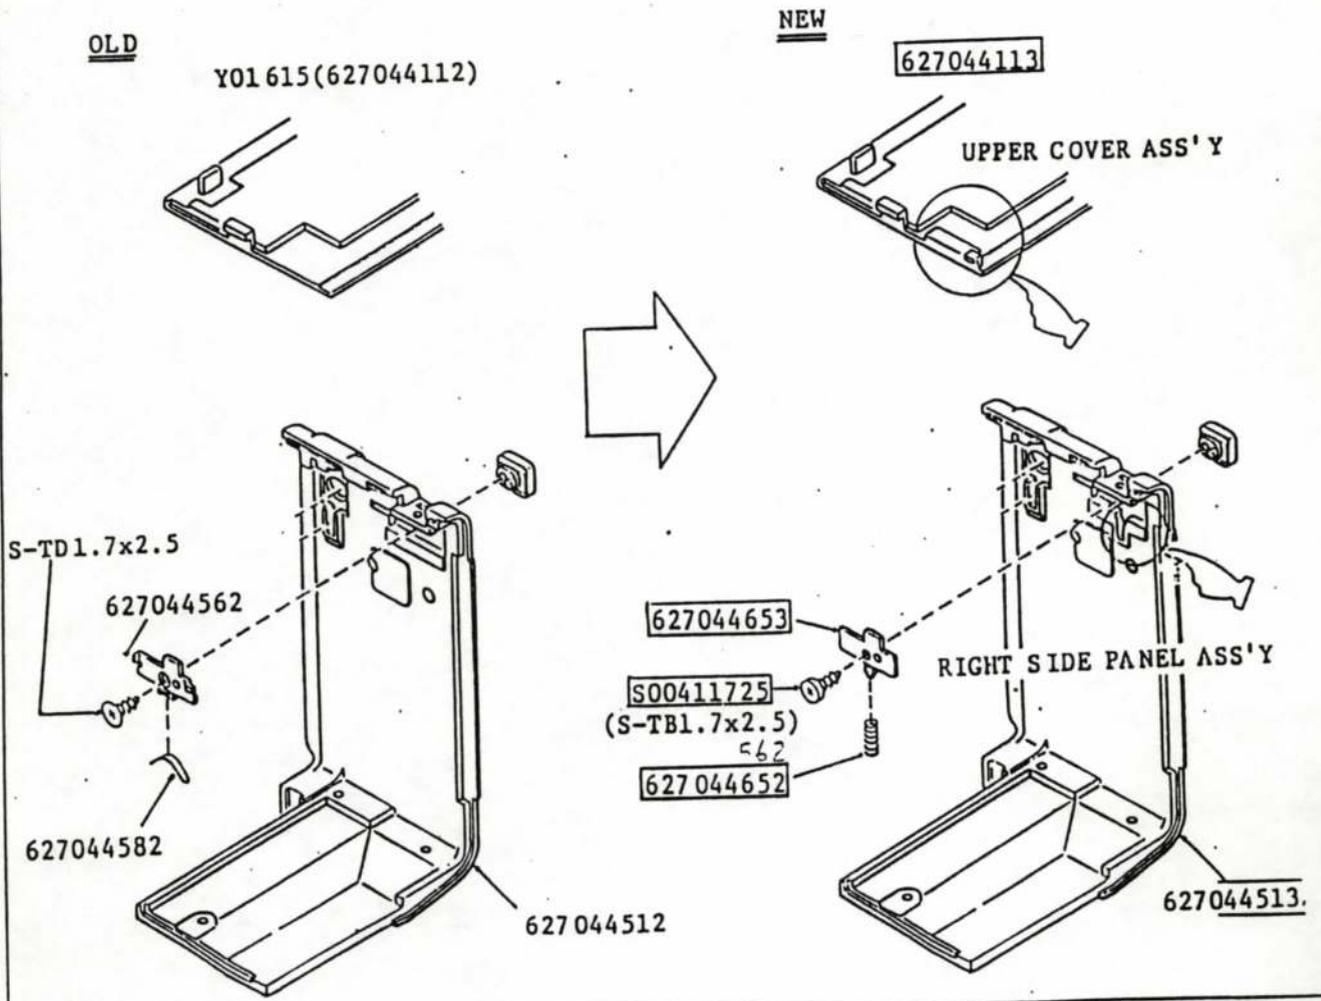
: Compatibility of new and old.....None

3. MODIFICATION DATE : From September, 1986.

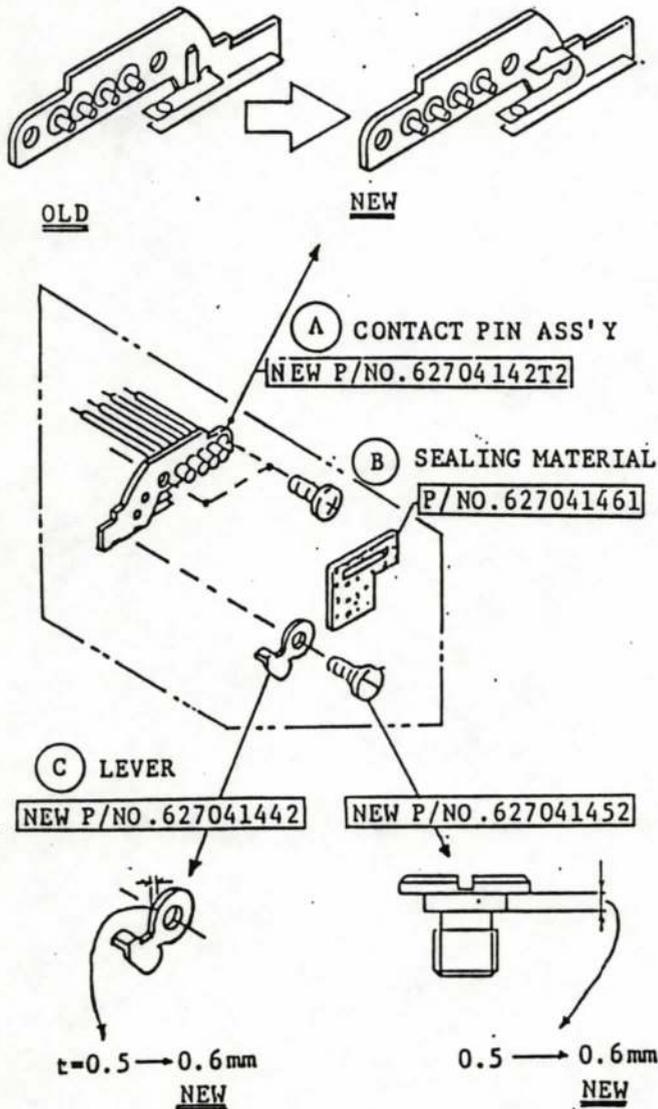
1. CAUSE

- 1) Contact of contact pin ass'y :Weakened
- 2) Light leak from space of contact pins.

2. MODIFICATION

- 1) Shape of contact.
- 2) Addition of B Sealing material.
- 3) Shape of C lever and it's screw.

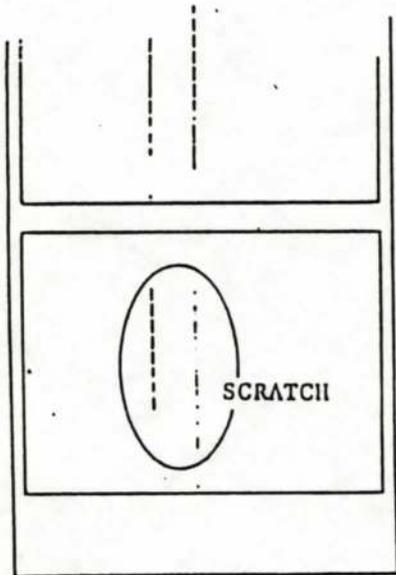
OUR REF.NO. 001

SCRATCH ON FILM SURFACE	1/2	87	1
-------------------------	-----	----	---

1. PHENOMENON

: Scratch on film surface at the 13th~15th exposure frame.

3. REPAIR STEP
