M645 SUPER

7 TECHNICAL BULLETIN

| NEW S. BUTTON GUIDE | 1/1 | 76 | 10 |

OUR REF.NO. 060

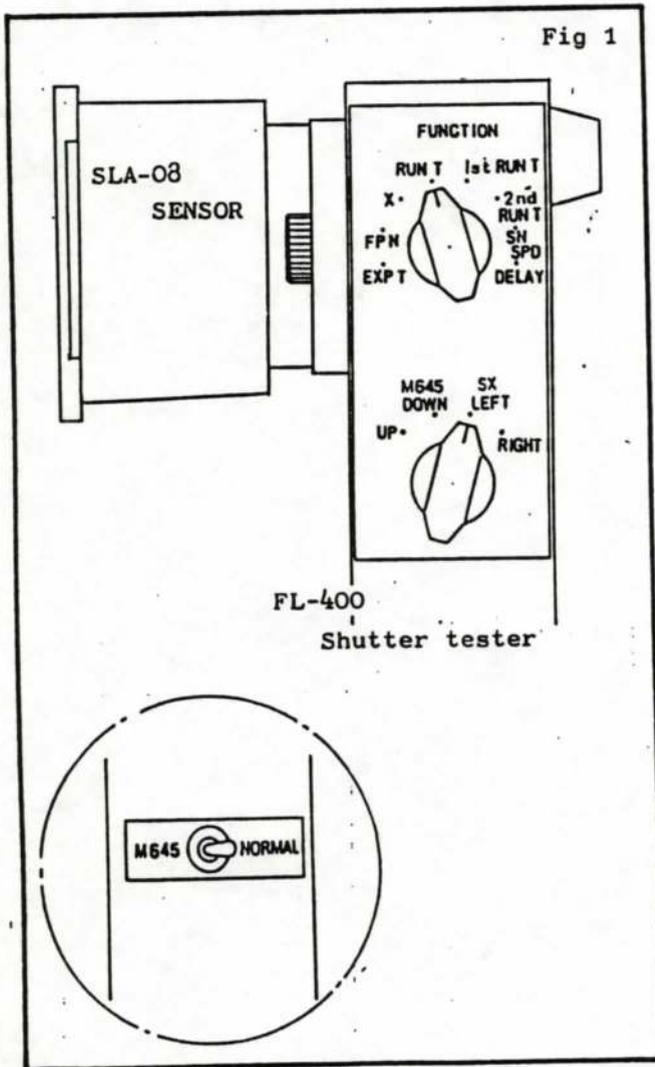
When using SLA-08 SENSOR for FL-400 shutter tester, following check and adjustment should be made.

1) Attach SLA-08 SENSOR to FL-400 and the set the selector switches as shown in Fig.1.

- A : RUN T
- B : SX LEFT
- C : NORMAL

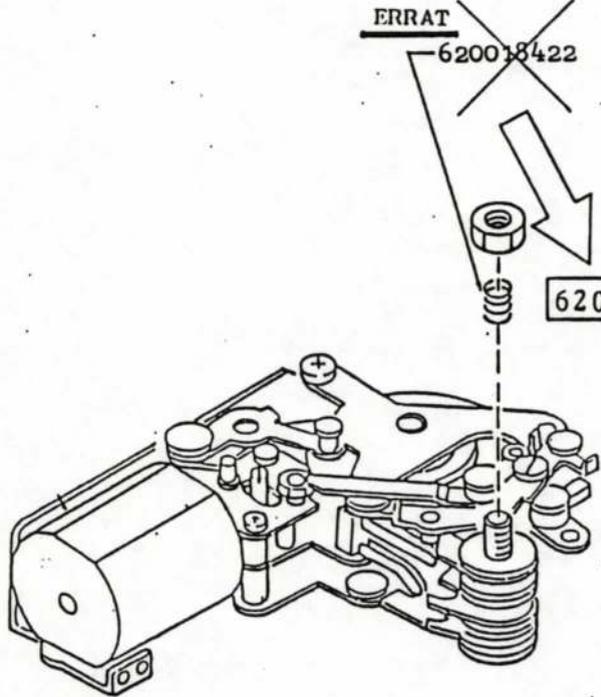
1. PURPOSE

: To facilitate adjustment of 1st curtain bounce the spring has been changed as shown in the drawing.

| ERRATUM | AMEND TO READ |
| 620018422 | → 620018442 |

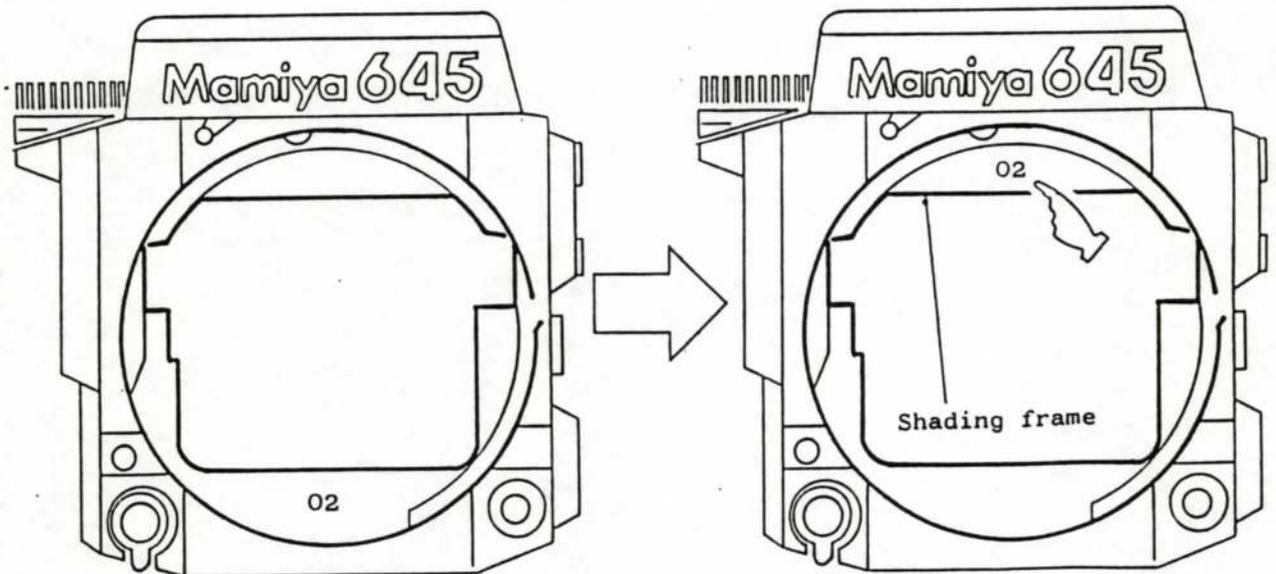
1. DISCRIMINATION : Modified body is still marked with "02" stamp.  
"02" stamped on the upper part of body front shown in to drawing below.
2. MODIFICATION DATE : From middle of October, 1986.

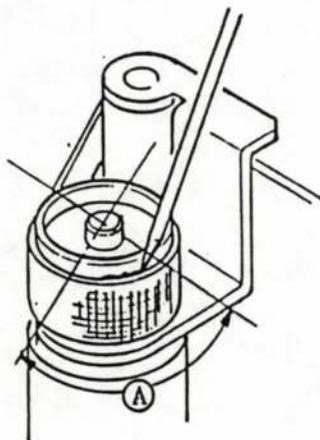
## SHUTTER CURTAIN RIBBON

PHENOMENON : The curtain ribbon was teard off.

If the shutter assembly is removed for repair, take the following steps.

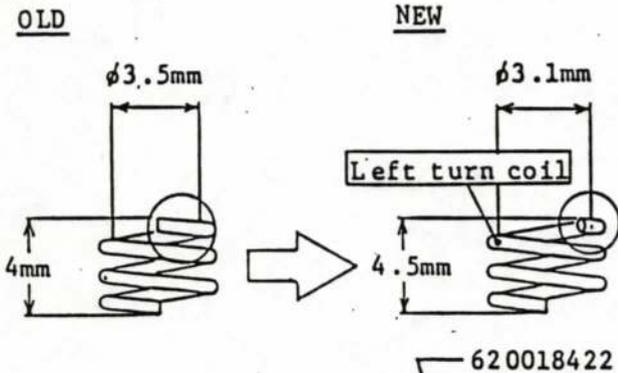
1. PURPOSE

: To facilitate adjustment of 1st curtain bounce the spring has been changed as shown in the drawing.
