OLYMPUS
35 DC
REPAIR MANUAL

35 DC

REPAIR MANUAL

MODEL	HOUSE CODE	FIG. 1/4
OLYMPUS 35 DC WITH BATTERY CHECKER	LEE-12N	
OLYMPUS OPTICAL CO., LTD. TOKYO, JAPAN

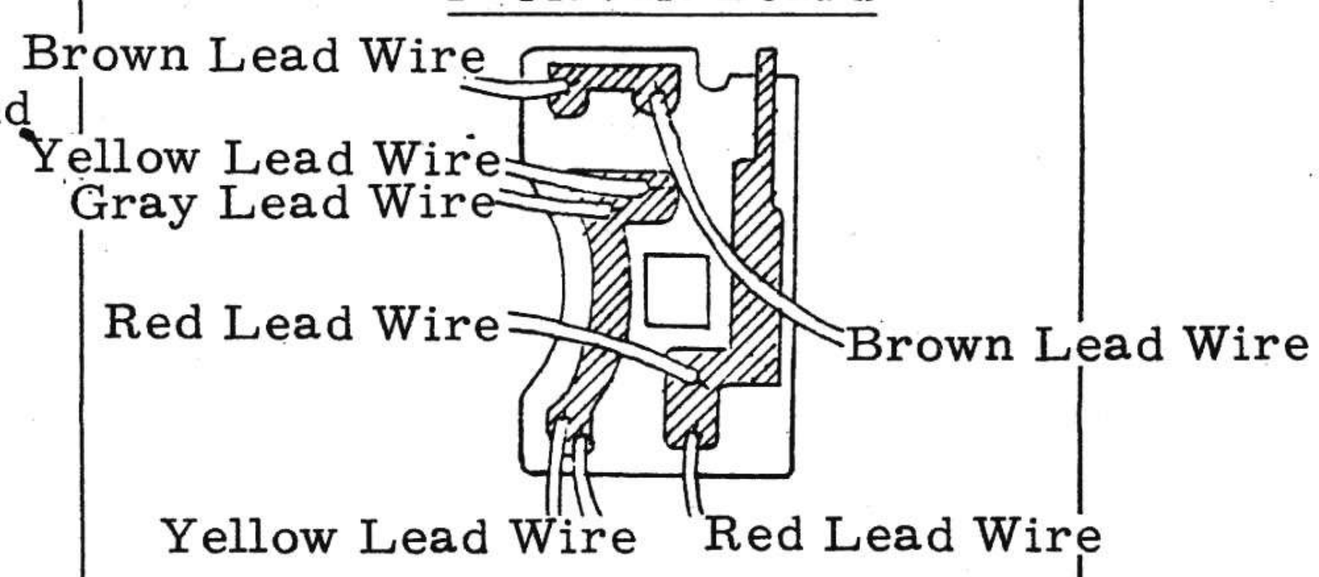
Cause	Remedy	Confirmation
and white lead wires soldering portion and the upper plate	deposition.	conduction.
4) Short-circuit of the F circuit board yellow and gray soldering portion and the upper plate	Correct the soldered portion. The lead wire connecting directions are as illustrated below. Soldering is to be done taking care not to make excessive solder deposition.

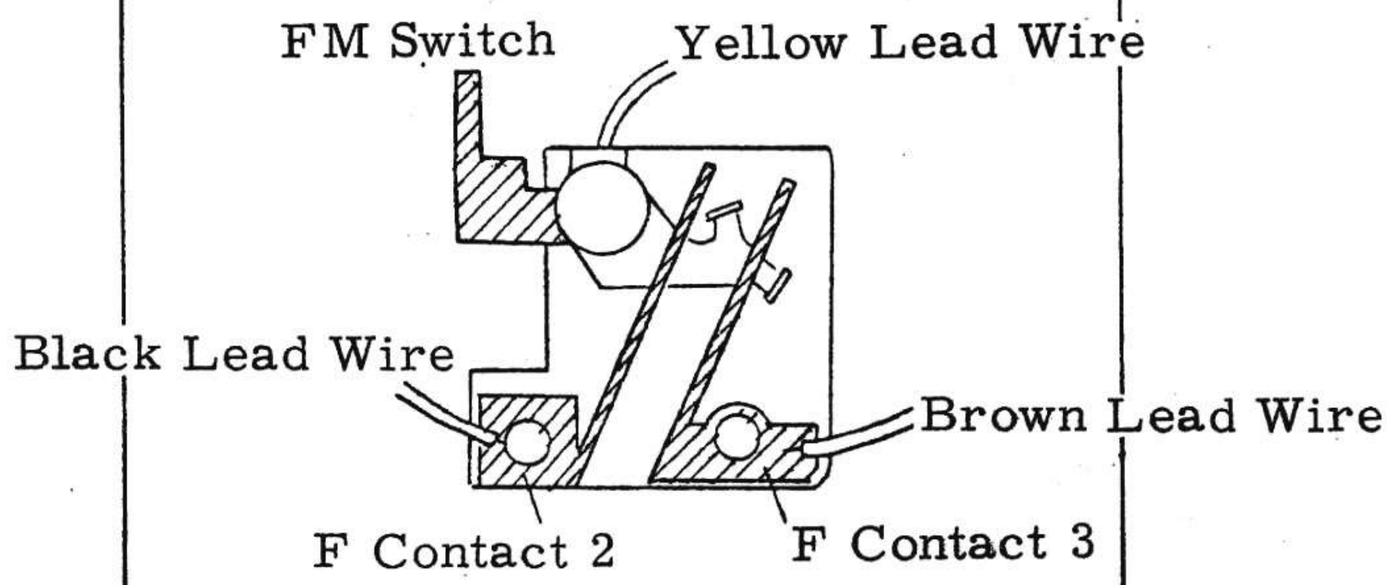
Cause	Remedy	Confirmation
1) FM switch is ON	Correct the contact in the direction to be set to OFF by means of a pincette. The lead wire soldering directions are as illustrated below. Soldering is to be done taking care not to make excessive solder deposition. FM Circuit Board

Confirm with a tester for the conduction of the brown lead wire, the black lead wire and the yellow lead wire of the FM switch. Normal if no conduction is detected.

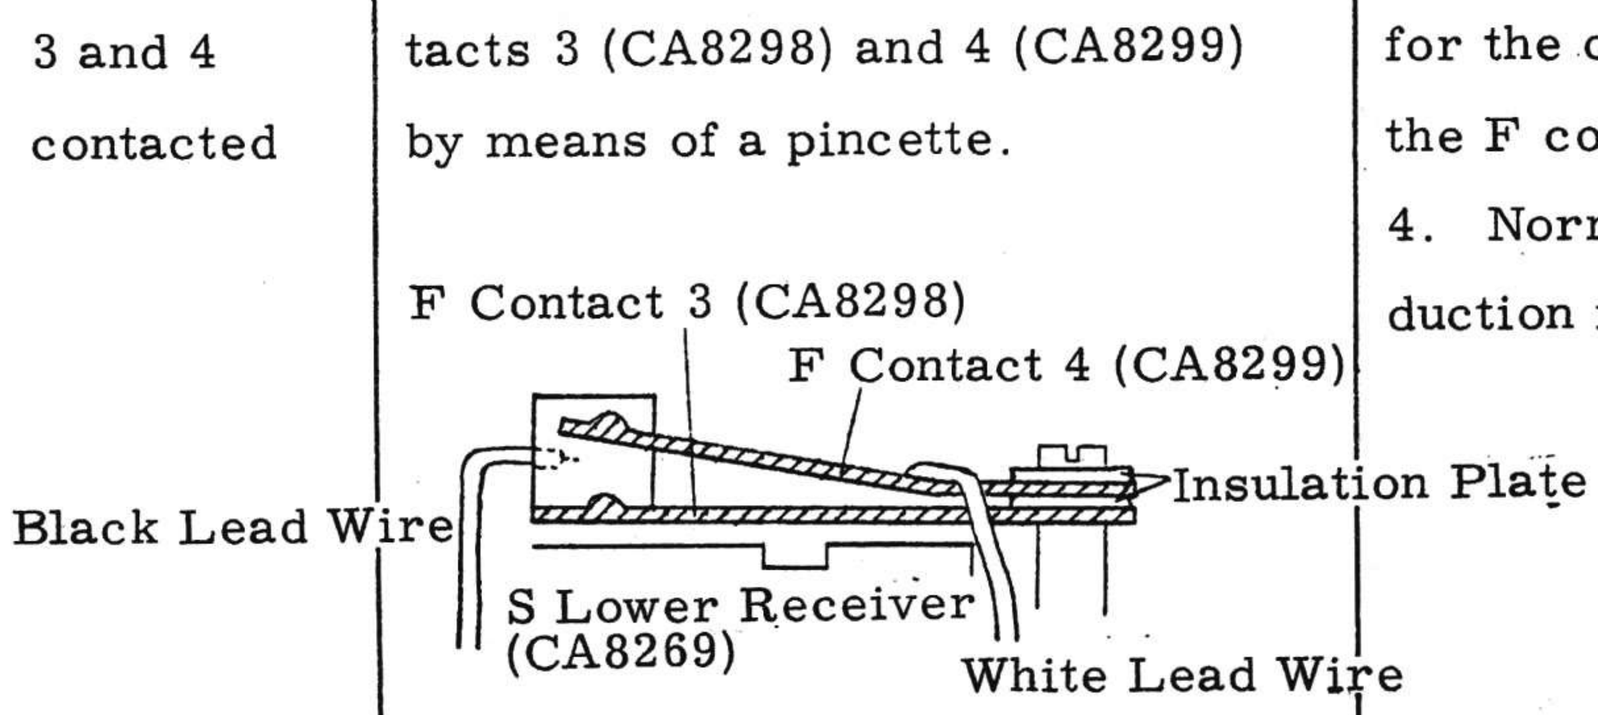
Cause	Remedy	Confirmation
3) F contact 3 and 4 contacted	Correct the shapes of the F contacts 3 (CA8298) and 4 (CA8299) by means of a pincette.

Confirm by a tester for the conduction of the F contacts 3 and 4. Normal if no conduction is detected.

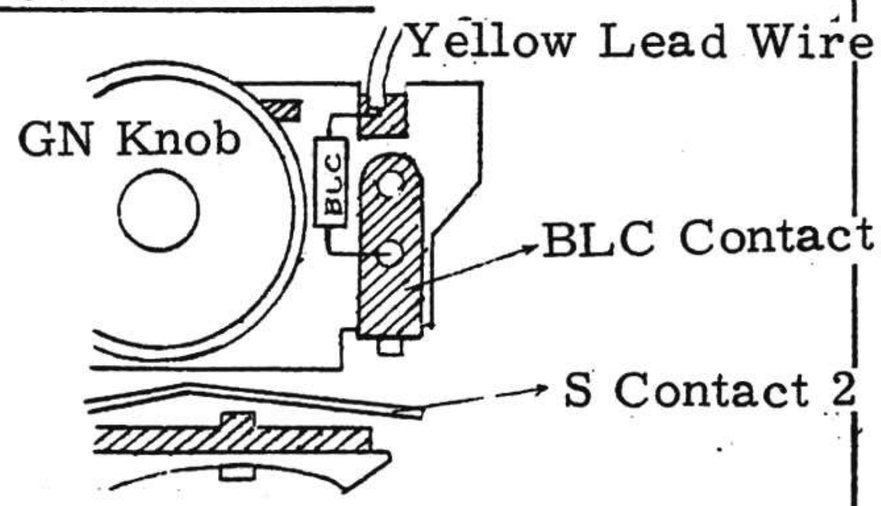
Cause	Remedy	Confirmation
1) Contact failure of S contact 2 and GN circuit board BLC contact	Clean the contacting portion of the S contact and GN circuit board BLC contact, correct the spring pressure of the S contact 2 in the pressure increasing direction by means of a pincette.	The exposure should be changed by about 1.5EV when the BLC button is depressed.
2) Defective soldering of BLC	Do the soldering again.	Same as the above.
3) Defective BLC	Replace it. GN Circuit Board

Same as the above BLC is 7 ~ 8 KΩ.

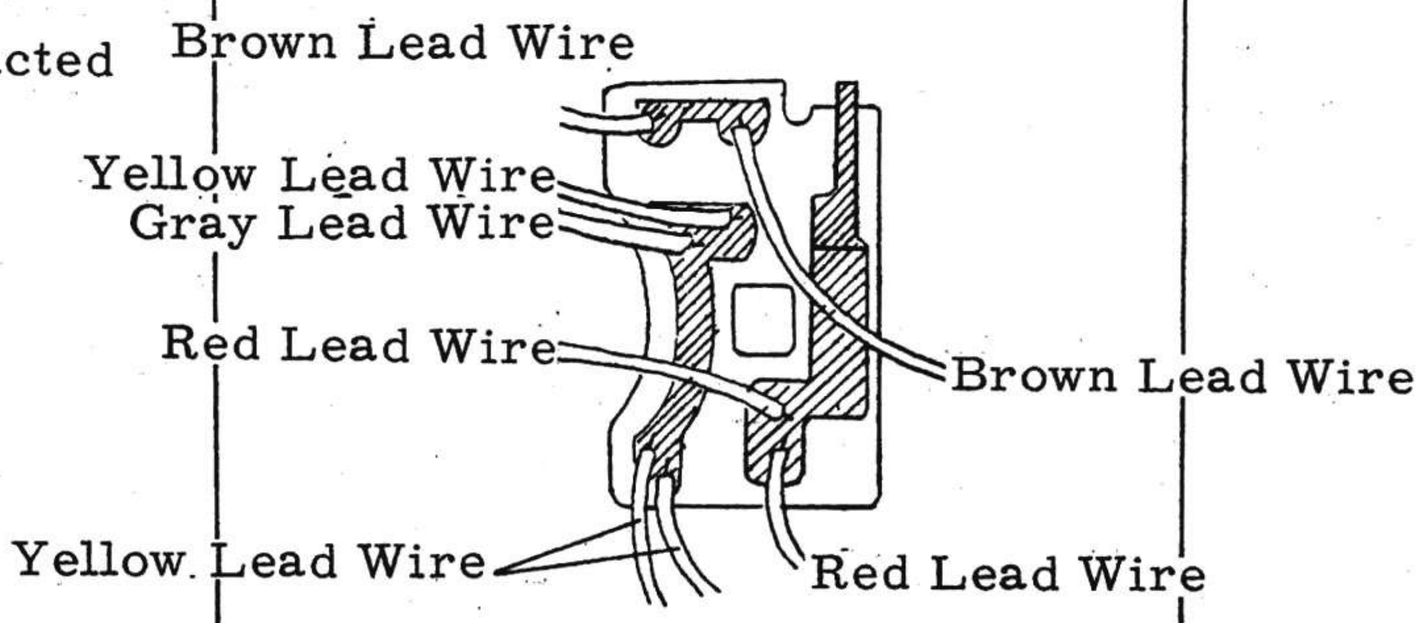
Cause	Remedy	Confirmation
1) F circuit board brown lead wire soldering portion and the upper plate contacted	Correct the soldered portion. The lead wire connecting directions are as illustrated below. Soldering is to be done taking care not to make excessive solder deposition. F Circuit Board

The shutter should be released when the FM switch is depressed with the GNO ring set to the maximum, the distance ring set to the closest and the CdS covered.

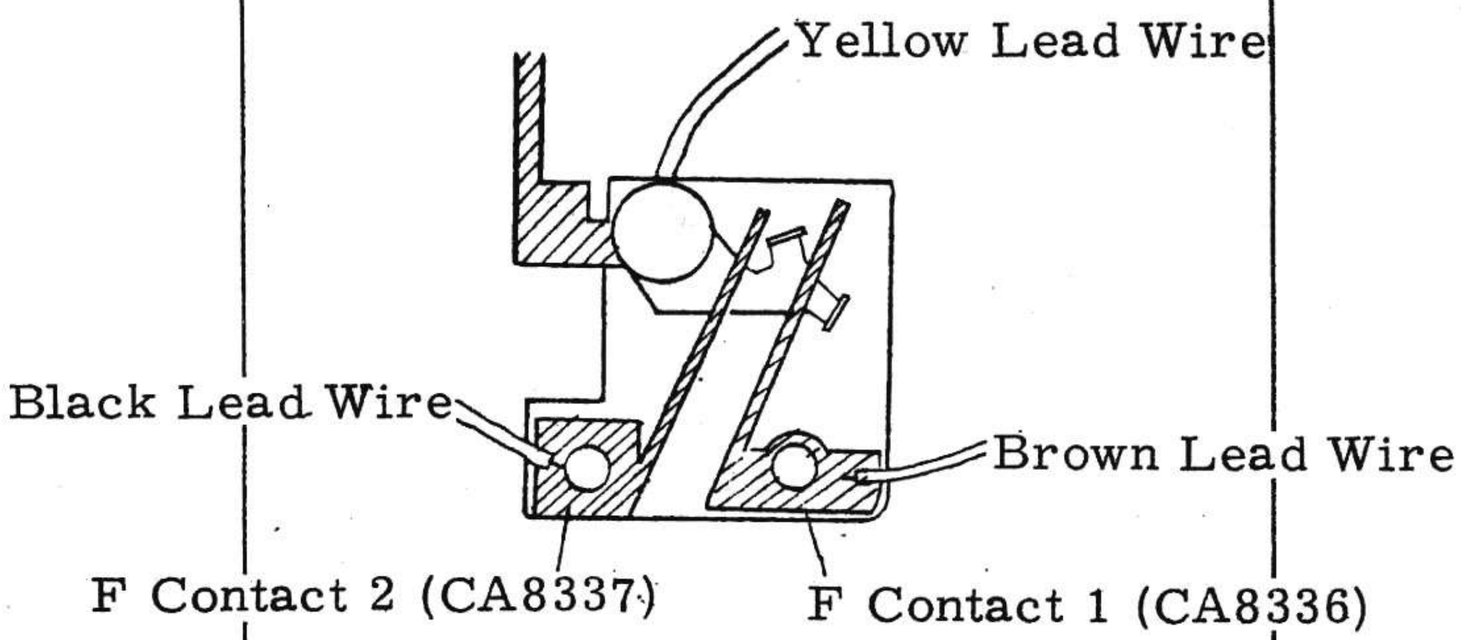
Cause	Remedy	Confirmation
2) Contact failure of FM switch and F contact	Clean the F contact portion, and correct the contact by means of a pincette. (Caution) Take care not to bend the contact excessively. If so, the switch is left closed.

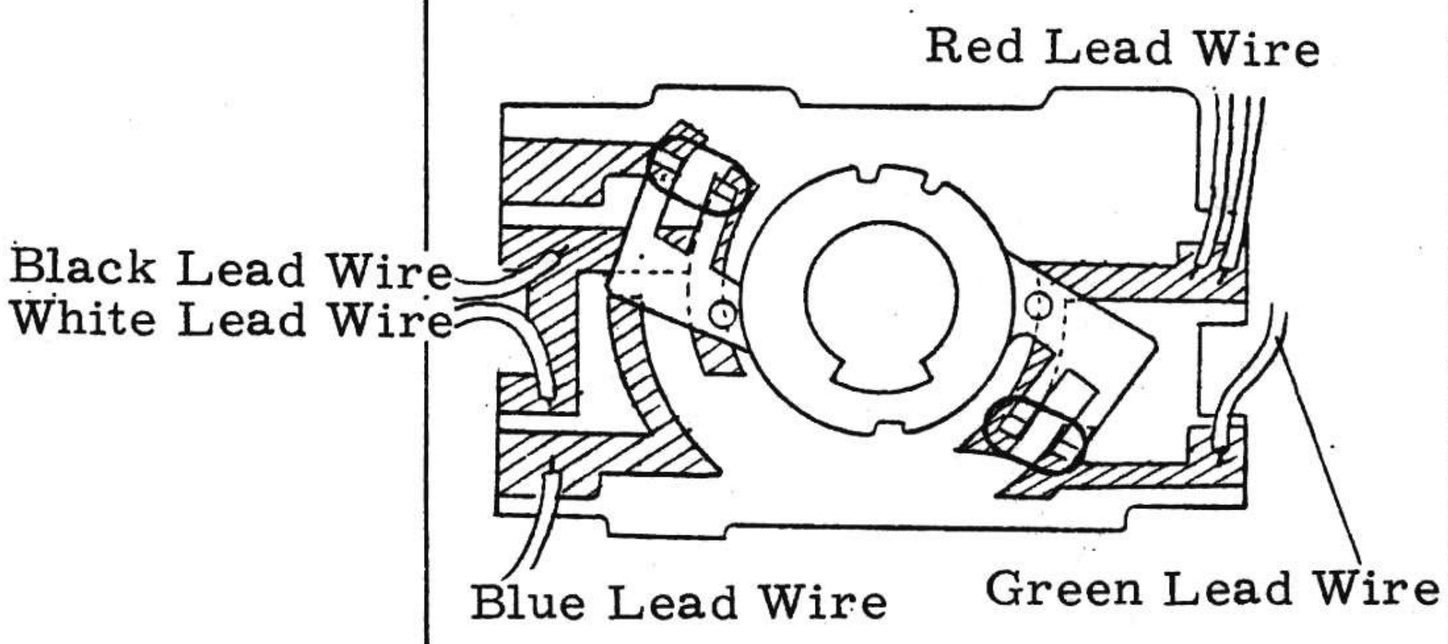
Same as the above.
3) Contact failure of MX contact and MX circuit board	When they are not conductive, correct the MX contact by means of a pincette, clean the contacting portion of the MX contact and the MX circuit board and apply thin coat of conductive agent (Electro-lub, Echo, etc).

Confirm with a tester for the conduction of the white and black lead wire soldered portions and the blue lead wire soldered portion of the MX circuit board when the MX lever is set to the EF (ϟ) mode. Normal if the conduction is detected. Confirm with a tester for the conduction of the yellow and red lead wire soldered

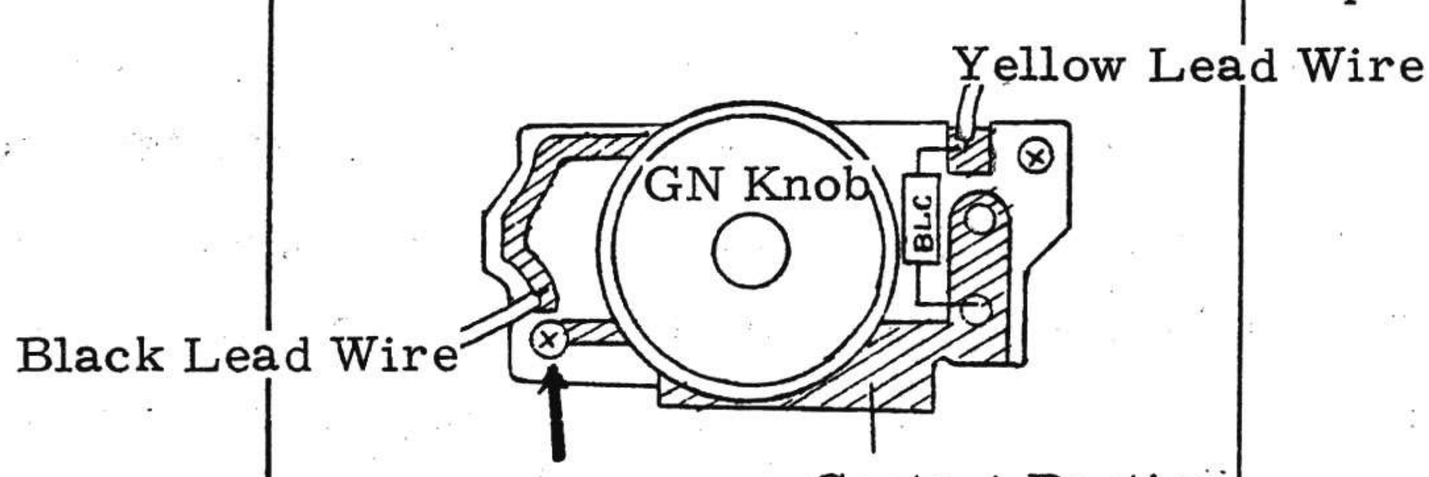
GN Circuit Board

Cause	Remedy	Confirmation
1) Defective body grounding of GN circuit board	Clean the contacting portion of the GN circuit board and the left side fixing screw (arrow marked in the illustration below), and then tighten it again completely. If the conduction is still incomplete even after the sufficient tightening of the screw, replace the GN circuit board.	Normal if the conduction is detected when confirming with a tester for the conduction of the black lead wire soldered portion of the GN circuit board and the body with the FM switch depressed.

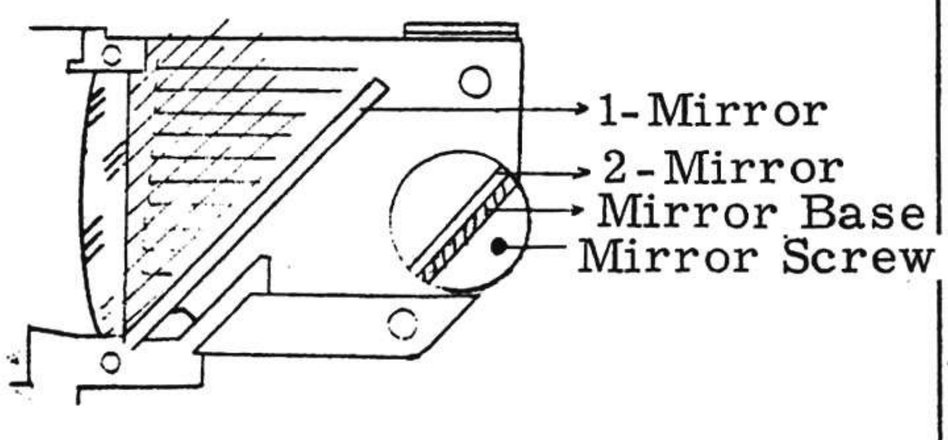
Cause	Remedy	Confirmation
1) Reflected image displaced upward	When the reflected image is displaced upward with respect to the transmitted image in viewing through the collimator with the mirror and lens cement not removed, turn the mirror screw (CA8097) clockwise.

Should not be displaced more than one line when checking by the collimator (f=600mm).
2) Reflected image displaced downward	Turn the mirror screw in the inverse direction to the above.	Same as the above.

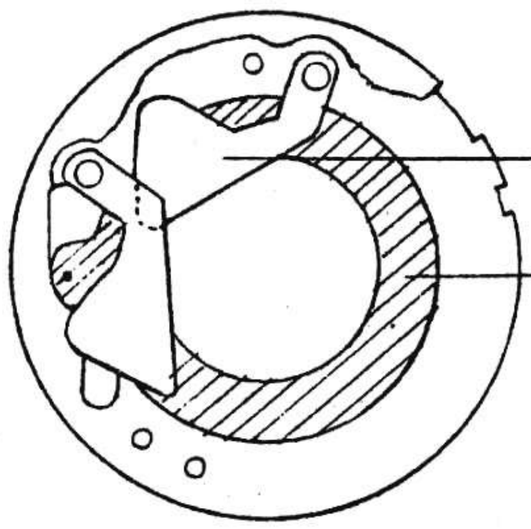
Cause	Remedy	Confirmation
1) Sector tenacious	Disassemble the shutter according to the disassembly procedure (Demounting of Shutter), and clean the lubricant exuding to the exposure blade (924-2031), external frame (924-0003), base plate (924-0001), ring base (924-2141) and ring (924-2019). The exposure blade mounting procedure is as shown in the illustration below.	Sector should surely operate.

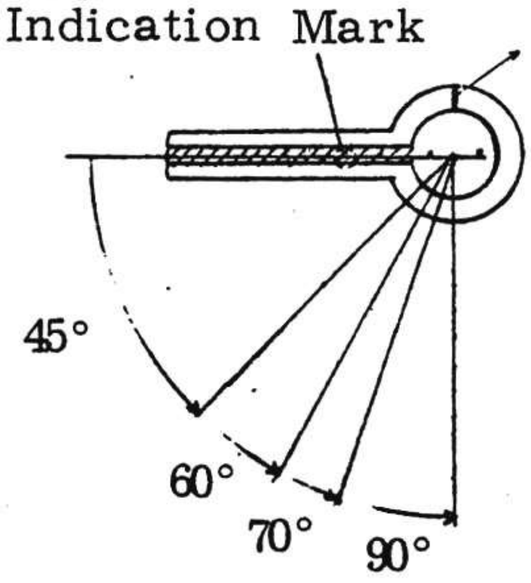
0 - 45°	Set impossible
45° - 60°	Set possible The starting operation is effected, but the shutter is not released.
60° - 70°	Starting operation is not effected.
70° - 90°	Normal operation.

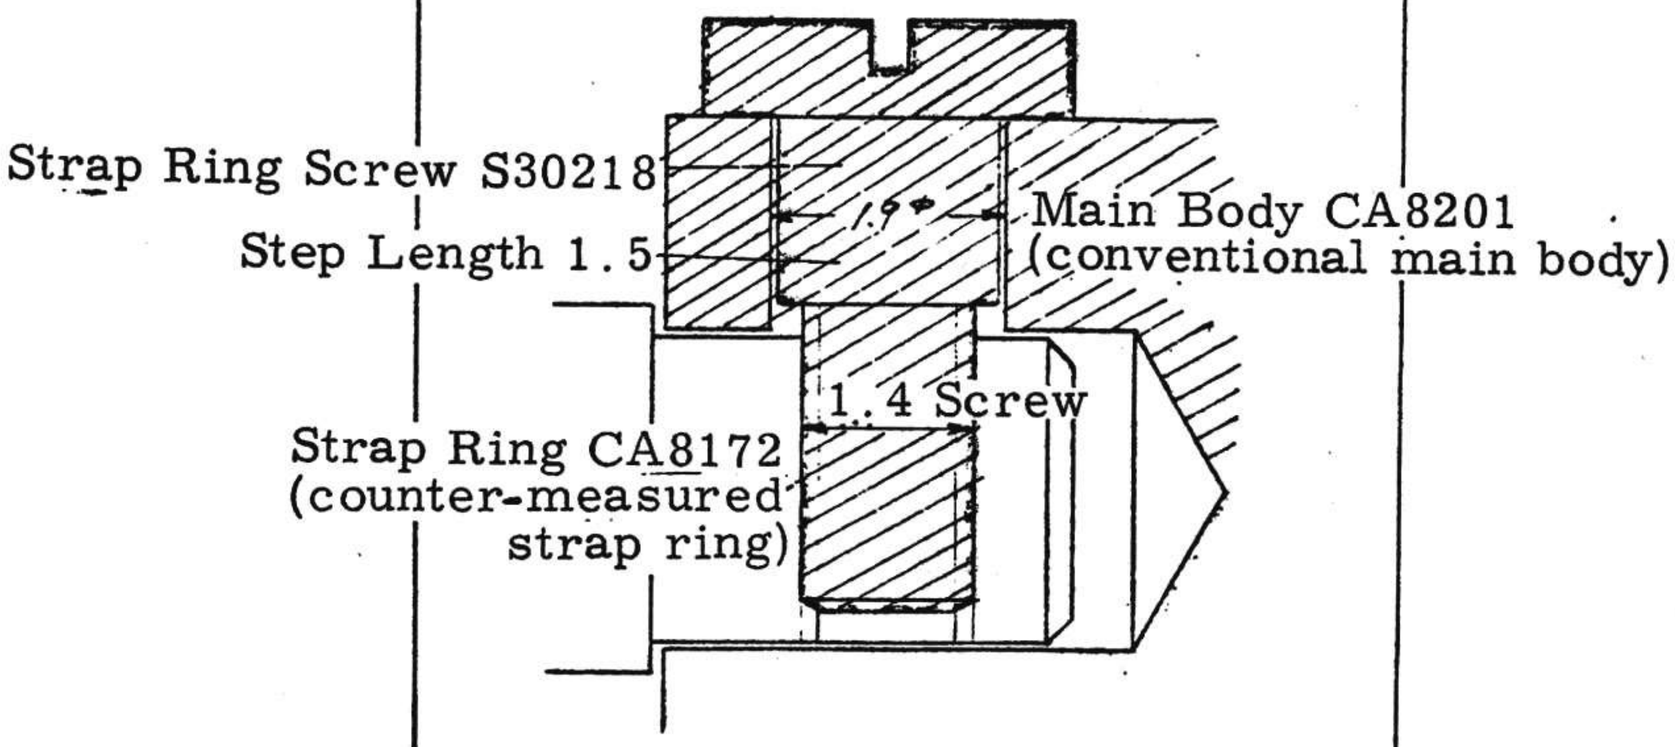
13. Strap ring breakage

Cause	Remedy	Confirmation
1) Strap ring breakage (easy-to-break due to 1.7ϕ screw hole in the strap ring of 2.6ϕ)	Although the main body (CA8361), the strap ring (CA8172) and PUK1.4x4SO (strap ring screw) are described in PR and RM, the main body (CA8201), the strap ring (CA8011) and PUK1.7x4SO (strap ring screw) are actually used as in the LEE-11. This strap ring is easy-to-break because of the left described reason. When the strap ring is broken, repair it in the following manner. o Replace the broken ring by the strap ring CA8172. o Mount the ring on the main body with the strap ring screw while leaving the main body as it is.

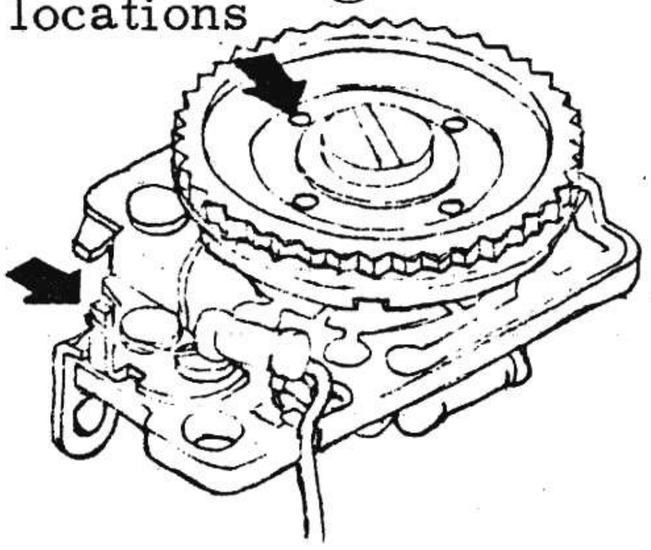
Gates at four locations

Rising

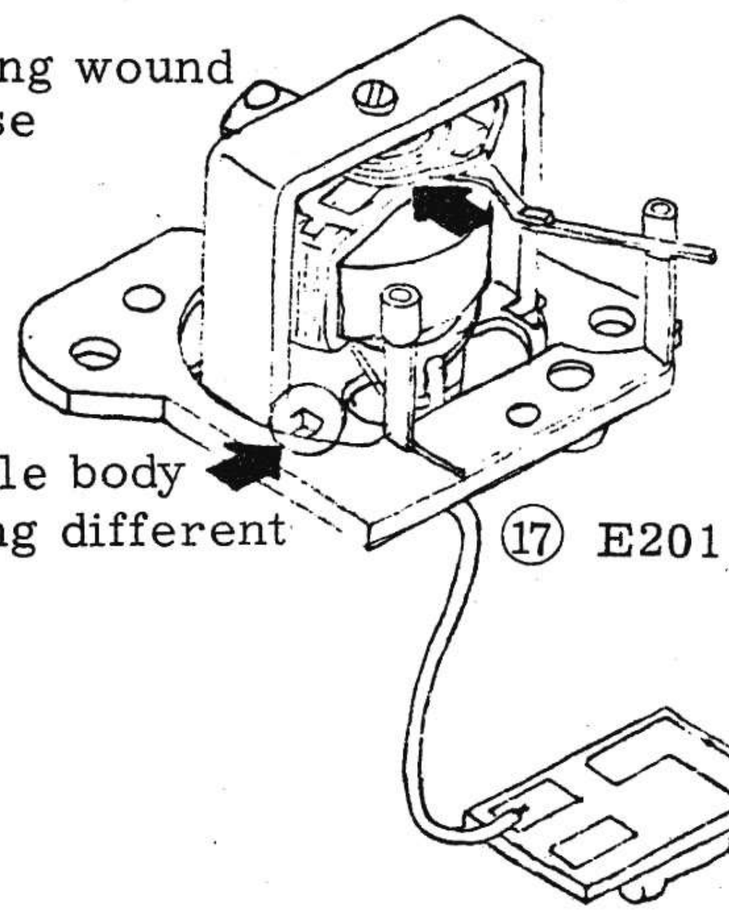
Hair spring wound in reverse

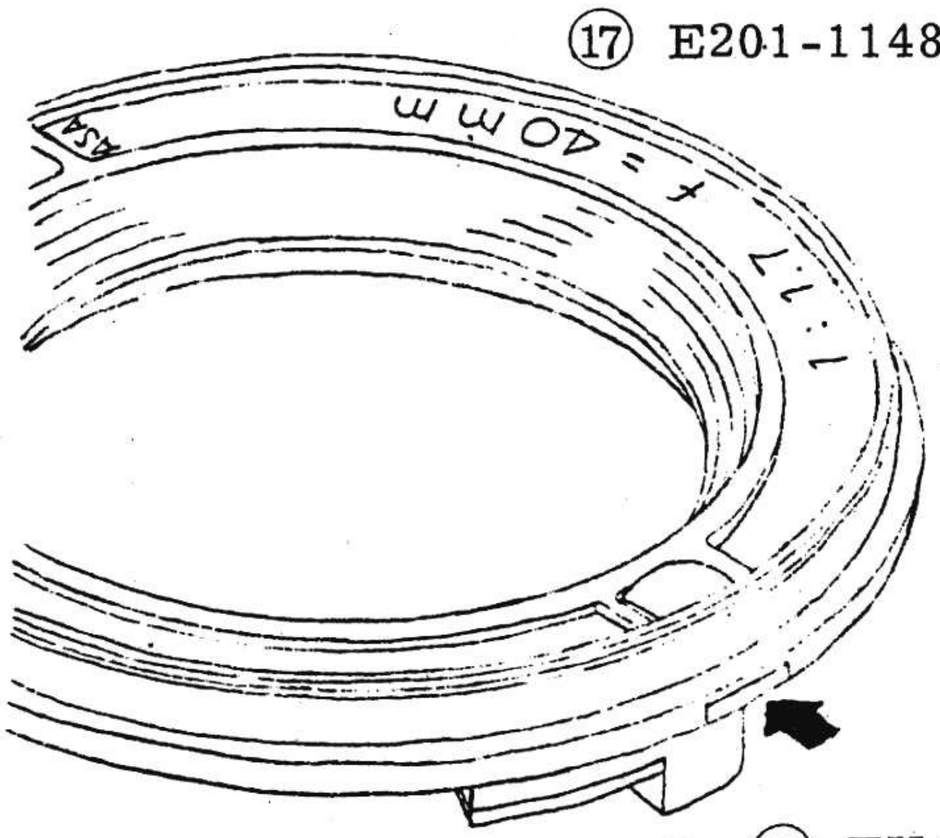
⑰ E201 METER

⑰ E201-114870

Rotation stopper fitting part position changed
