ETR Si

FILM BACK-EI

REPAIR MANUAL

Back Repair

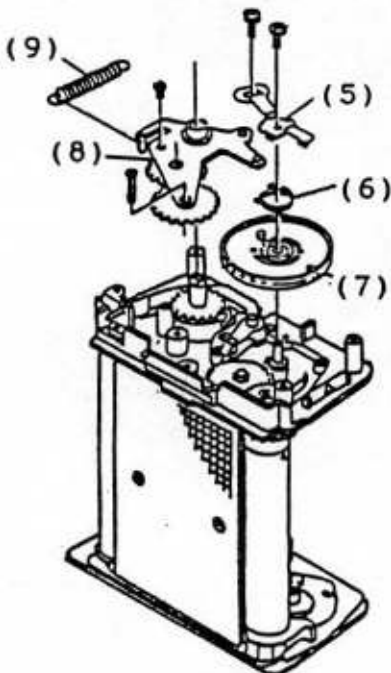
Sketch	Explanation						
<p>[Figure 2]</p>

<p>Counter and winding base plate removal</p> <ol style="list-style-type: none">1. Remove the counter stopper (5). Screws: special panhead M1.7x2.5-B (0116230) x 2 screws2. Remove counter gear SP (6) and the 120 or 220 dividing plate set (7).3. Remove the spring (9) and then remove the winding base plate (8). Screws: self-tapping panhead type 3 M2.0x8.0-B (95885807) x 2 screws self-tapping type 1 M2.0x 4.0-B (95875407) x 1 screw --- [Figure 2]						
<p>[Figure 3]</p>

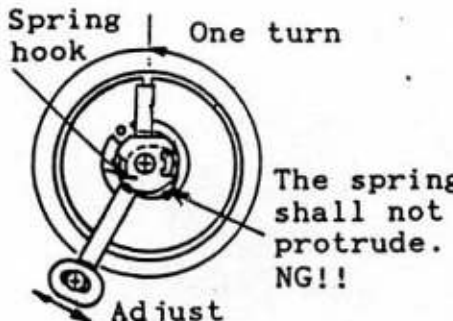
<p>* Reassembly notes</p> <ol style="list-style-type: none">o Reassembling the counter stopper (5)a. Hook the spring (6) at (5) and lightly tighten the two special panhead screws.b. Rotate (7) one turn counterclockwise and lightly tighten the special panhead screw. (Be careful when installing the spring; otherwise, the counter will not return.) --- [Figure 3]c. Load the back with film, mount the back on the camera and adjust the start position with (5).d. Tighten the special panhead screw and lock with Plio-Bond.						
<p>[Figure 4]</p>

<p>Start mark S position mark</p> <table><tr><td>For 120</td><td>A216mm</td><td>B232mm</td></tr><tr><td>For 220</td><td>A226mm</td><td>B242mm</td></tr></table> <p>o Ok if within range C.</p> <div style="display: flex; justify-content: space-around; align-items: center;"><div style="text-align: center;">

<p>OK</p></div></div>	For 120	A216mm	B232mm	For 220	A226mm	B242mm	<p>Start position adjustment</p> <ol style="list-style-type: none">1) Load the back with film and mount it on a camera with no lens.2) Advance the film to the first frame.
For 120	A216mm	B232mm					
For 220	A226mm	B242mm

- 3) Align the counter mark ▼ with the center of the numeral "1" and lock with Plio-Bond.
- 4) Press the release button and observe the film S mark from the front of the body. [Figure 4]
(When the mark is not in the correct position, adjust by shifting the counter slot.) [Figure 3]
- 5) The character "S" shall be at the counter mark ▼ when the rear cover is opened and the counter resets. Also check if the index mark is aligned from frame 1 to 15. [Figure 5]

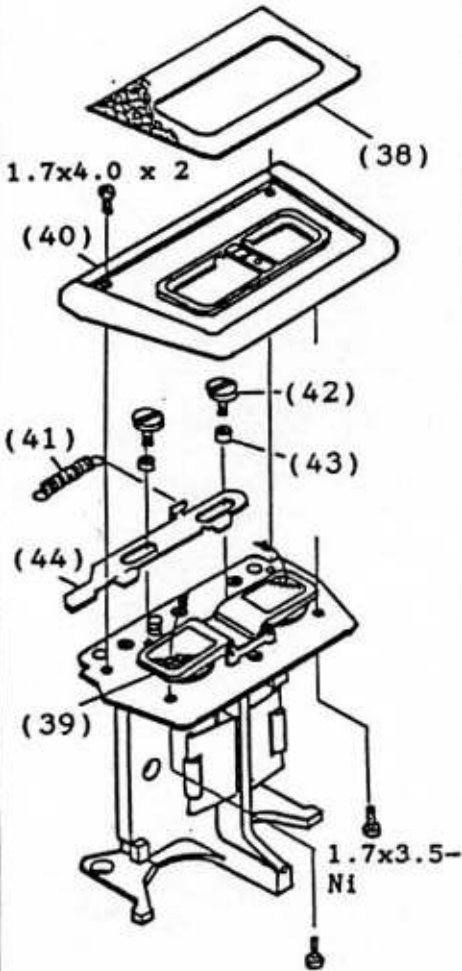
Sketch	Explanation
<p>[Figure 10]</p>

<p>o After the back winding gear (C) (29) is reinstalled, the spool claw (31) shall only rotate clockwise when pushed with the fingers.</p> <p style="text-align: right;">--- [Figure 9]</p> <p><u>M. left side cover and spool holder lock removal</u></p> <ol style="list-style-type: none"> 1. Peel off the leatherette (38), remove the screws, spread the spool holder (39) by pressing up on the back and remove the M. left side cover (40) [120] or [220]. <p>Screws: panhead type 1 M1.7x4.0-B (95813407) x 2 screws self-tapping panhead type 1 M1.7x3.5-Ni (95873355) x 1 screw self-tapping panhead type 1 M1.7x3.5-B (95873357) x 1 screw</p> <ol style="list-style-type: none"> 2. Remove the spring (41), remove the two guide screw B (42) and remove the two guide collar B (43) and spool holder lock (44). <p style="text-align: right;">--- [Figure 10]</p>
<p>[Figure 11]</p>

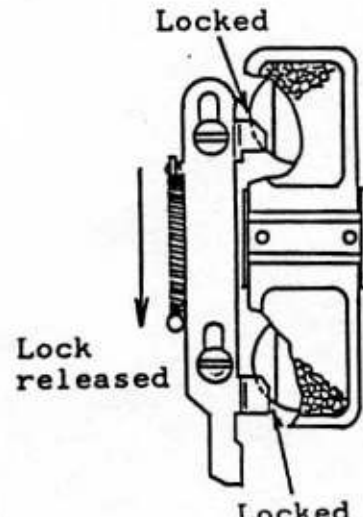
<p>* Reassembly notes</p> <p>o After reassembling the spool holder lock (44) and sliding it upward, the spool holder (39) should not move upward when pushed from the back. Also, (44) shall return properly.</p> <p style="text-align: right;">--- [Figure 11]</p> <p>o After reassembling the M. left side cover (40) [120] or [220], the spool holder (39) shall be moved only by the force of the flat spring without slipping.</p>

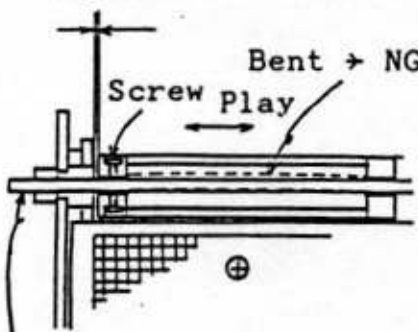
Sketch	Explanation
<p>[Figure 14]</p> <p>Adjust the gap to about 0.1mm and tighten the screw.</p>

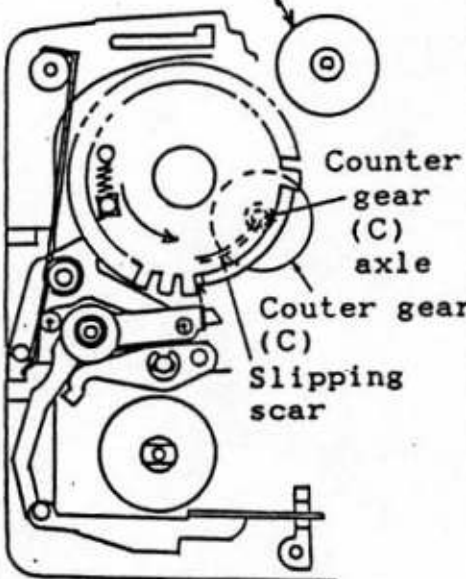
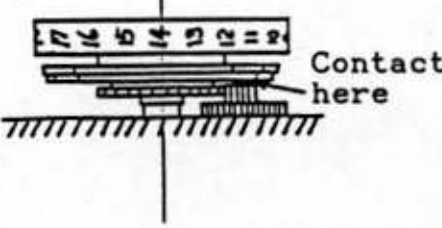
<p>Roller axle</p>	<p>The film will not advance to the 15th frame</p> <p>Is the start position accurate? NO → Check and readjust.</p> <p style="text-align: center;">↓ Yes</p> <p>Does the axle counter roller rotate smoothly? NO → The roller axle bent and no play in the counter roller.</p> <p style="text-align: center;">↓ Yes</p> <p>Is there foreign matter caught in the gear? NO → Clean the gear.</p> <p style="text-align: center;">↓ Yes</p>
<p>[Figure 15]</p> <p>Counter roller A</p>

<p>Is the counter gear (C) axle contacting the back side of the dividing plate? → File off part of the (C) axle.</p> <p style="text-align: right;">[Figure 15]</p>

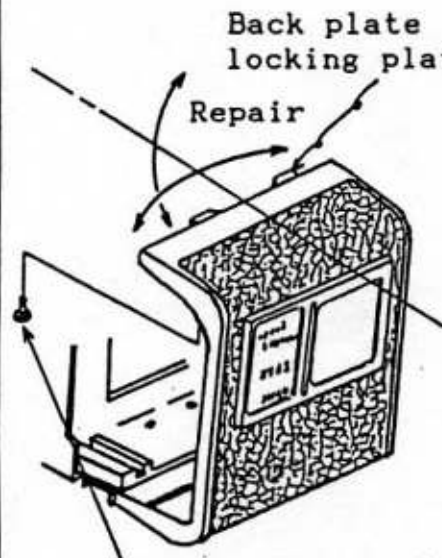
<p>Back plate locking plate</p> <p>Repair</p> <p>Panhead type 1 M2.0x3.0-B (95815307) x 2 screws</p>	<p>The rear cover will not close.</p> <p>Check if the rear cover touch against the inner frame. NO → Twist the rear cover to correct it.</p> <p style="text-align: center;">↓ Yes</p> <p>Check if the rear cover locking plate touch against the connecting plate. NO → Spread the rear cover to correct it. Locking plate screws loosened.</p> <p style="text-align: right;">[Figure 16]</p> <p>The rear cover will not open.</p> <p>Check if the rear cover opener lever works smoothly. NO → The rear cover is spread excessively. Locking plate screw loosened.</p> <p>Out of grease. (Liqui-Moly LM-83) Replace the rear cover opener lever. (Use the locating jig - 02920500AJ)</p> <p style="text-align: right;">[Figure 17]</p>
<p>[Figure 17]</p> <p>Special panhead M1.7x2.5-B (01162230) x 2 screws</p> <p>Panhead type 1 M1.7x2.5-B (95813257) x 8 screws</p>

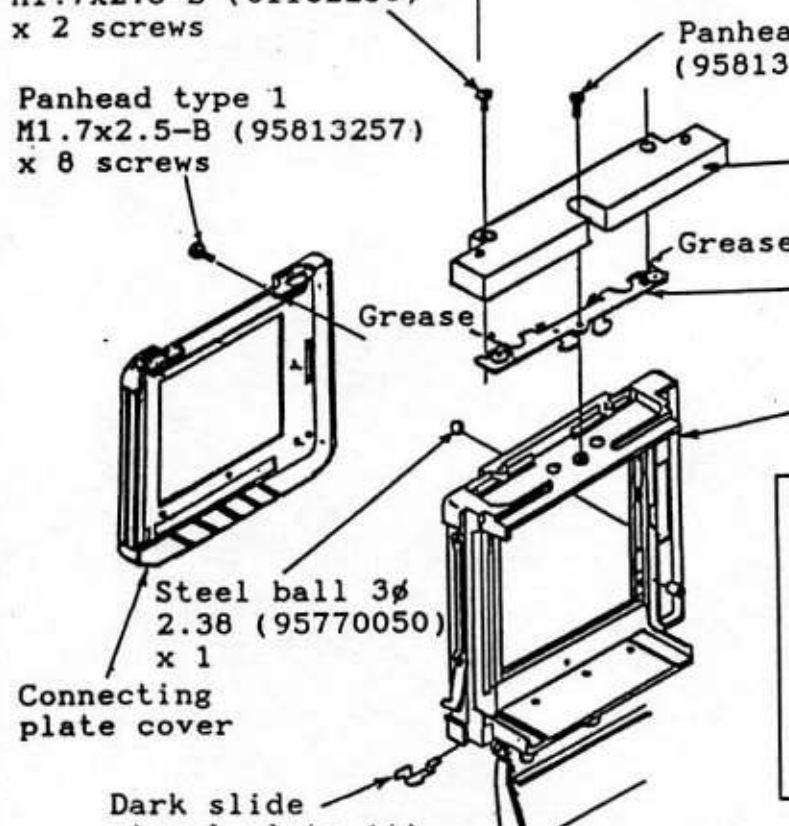
<p>Steel ball 3ø 2.38 (95770050) x 1</p> <p>Connecting plate cover</p> <p>Dark slide signal plate (A)</p> <p>Connecting plate</p> <p>02920500AJ</p> <p>Panhead type 1 M1.7x3.5-B (95813357) x 1 screw</p> <p>Grease</p> <p>Grease</p> <p>Rear cover opener lever (coat the two slots with Liqui-Moly LM-83)</p>	<p>Note: When repairing and fitting the rear cover, make sure that there is no gap larger than 0.3mm in the connecting plate cover and rear cover (to prevent light leaks).</p>
