M645 SUPER

7 TECHNICAL BULLETIN

NEW CONTACTS FOR CONNECTOR N

NEW RELEASE PLATE FOR AUTO BELLOWS

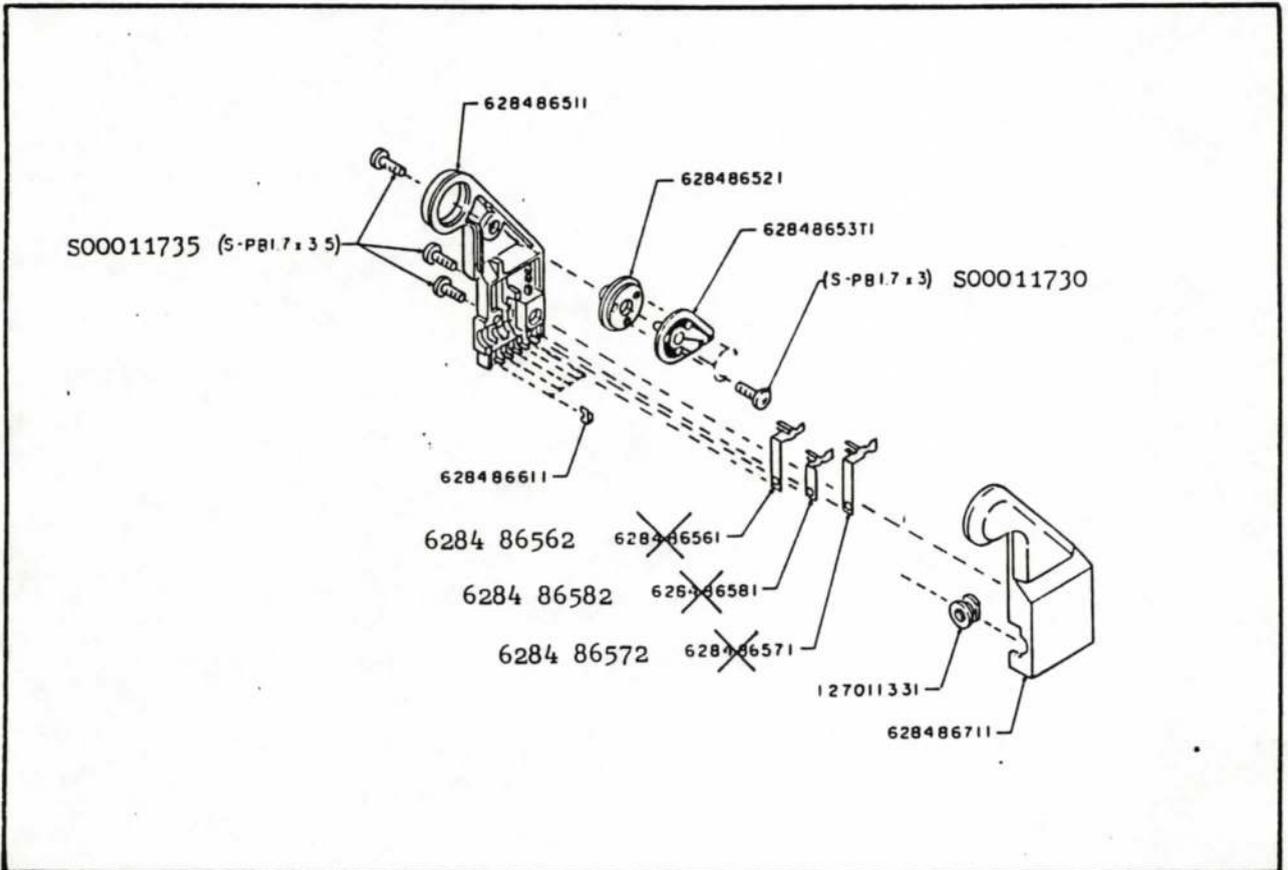
- 1. CAUSE : Contact B,C, and D : Weakened.
- 2. MODIFICATION : Material of contact B,C, and D : Changed.
- 3. MODIFICATION DATE : Since 1987 March production.

New P/No. 6284 86562 Contact D
 6284 86582 Contact B
 6284 86572 Contact C

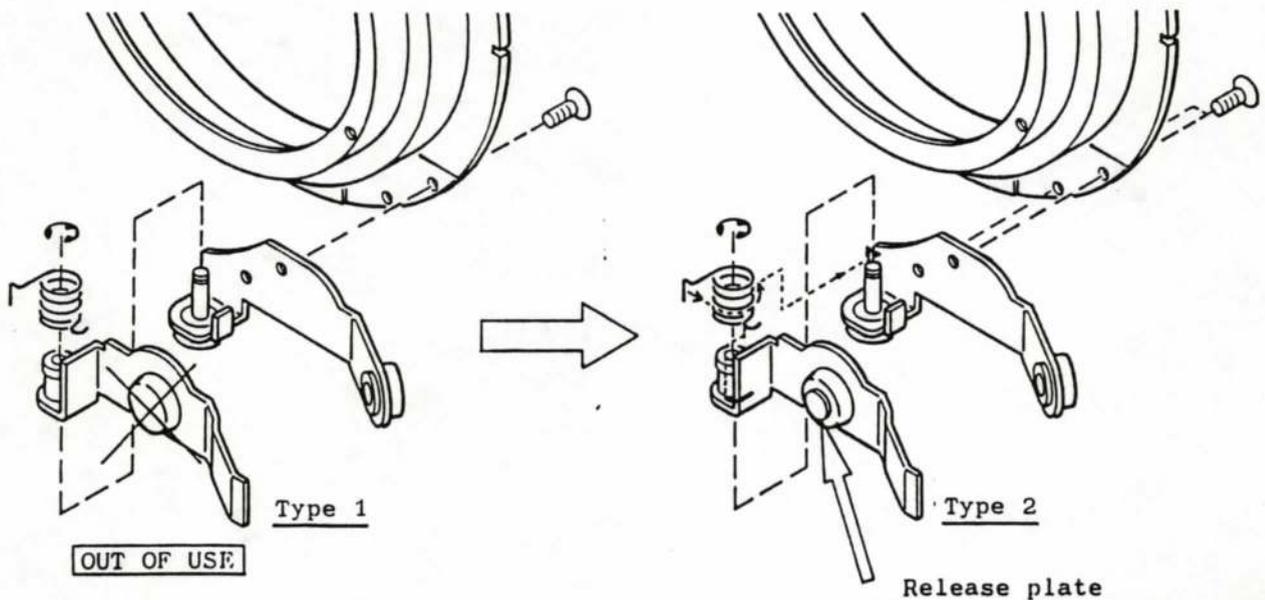
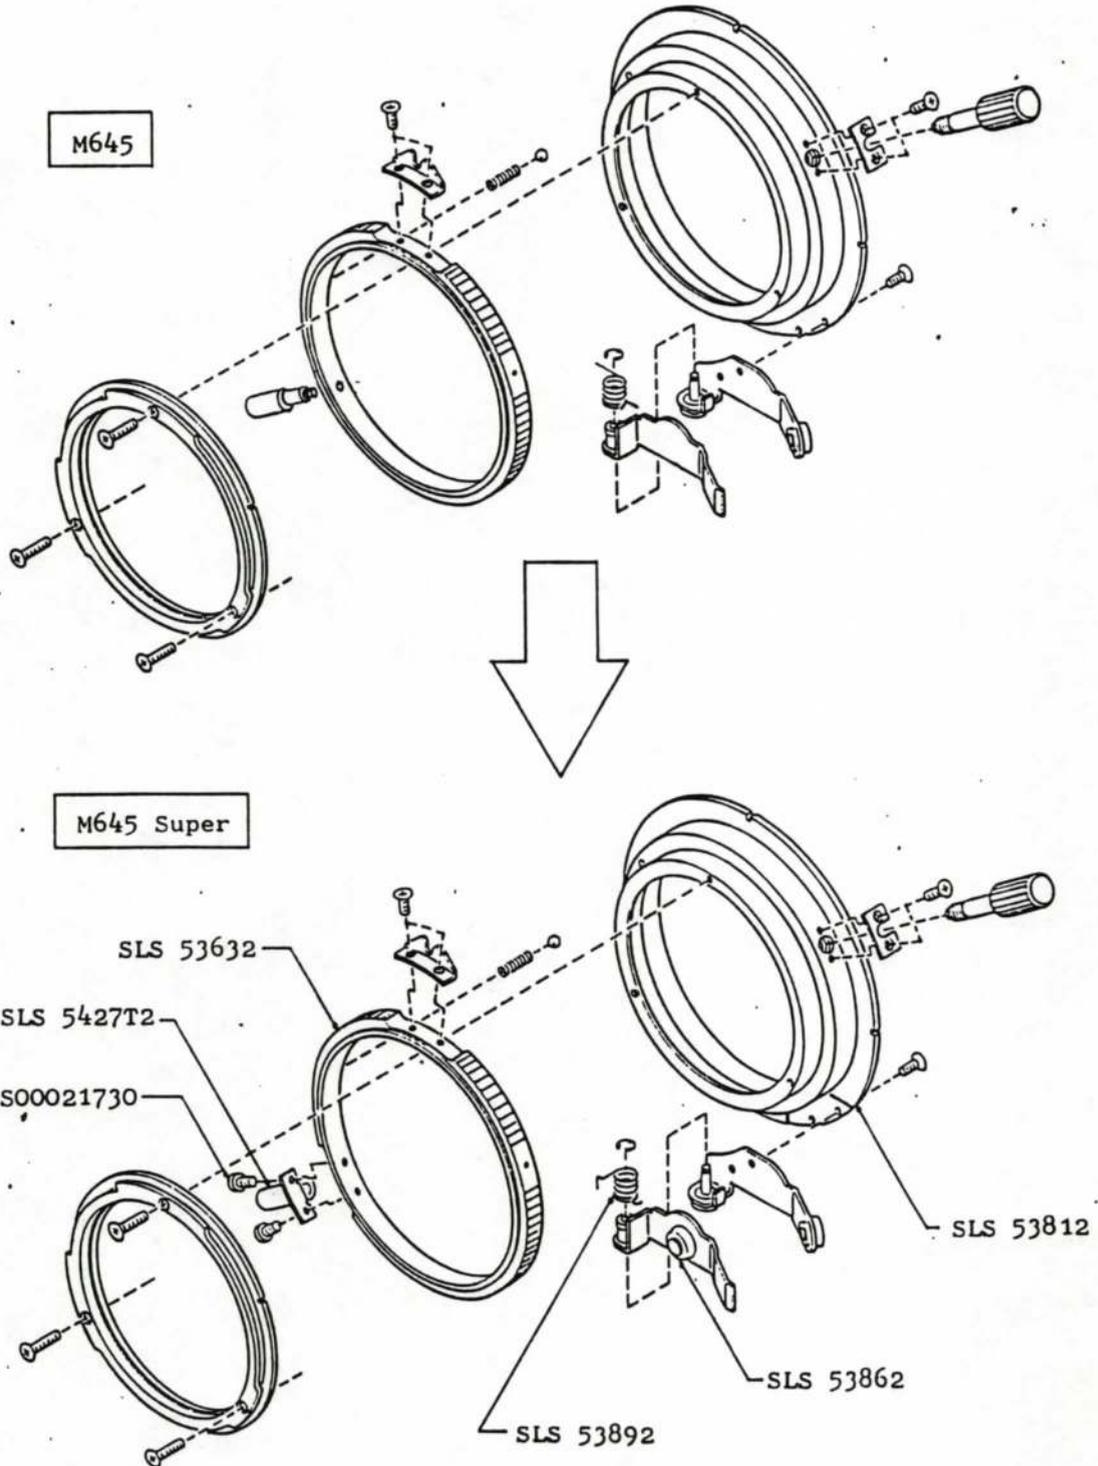
1. CAUSE : Release plate(type 1) does not push the release button of body.

2. MODIFICATION : Shape of release plate.

4. REPAIR STEP : Replacement of release plate (type 2)
