MINOLTA XG UPDATE

Note: This list of updates applies to models earlier than the XG-M (XG-7, XG-1, XG-9). The XG-M already has the revisions noted.

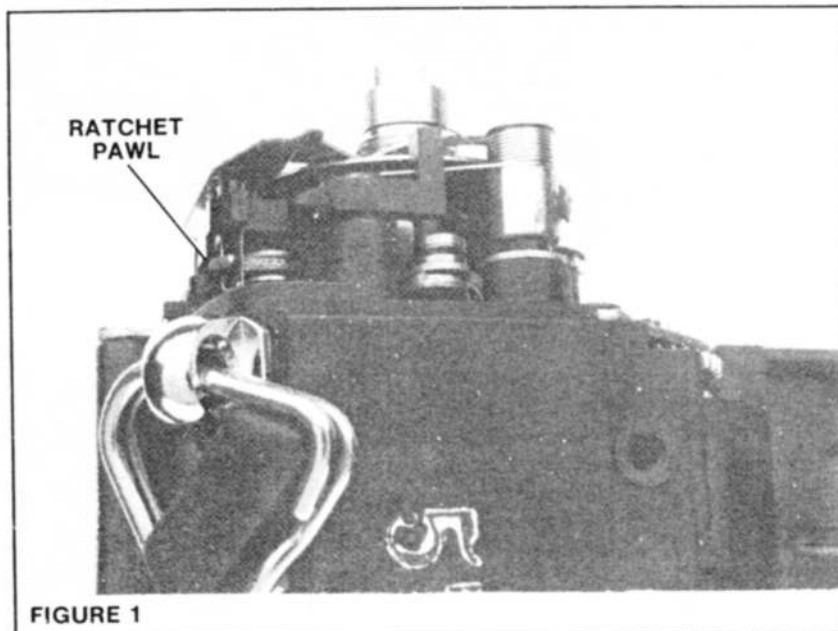
FIGURE 1

1. The ratchet pawl that engages the wind ratchet now mounts to the base plate rather than to the underside of the counter assembly, Fig. 1. If you don't get the ratchet during the wind stroke, check to see if the post for the pawl has come loose from the base plate. The normal symptom is that the camera comes in jammed—the mirror is up, but the shutter is already in the released position. You can restake the post after removing the base plate.

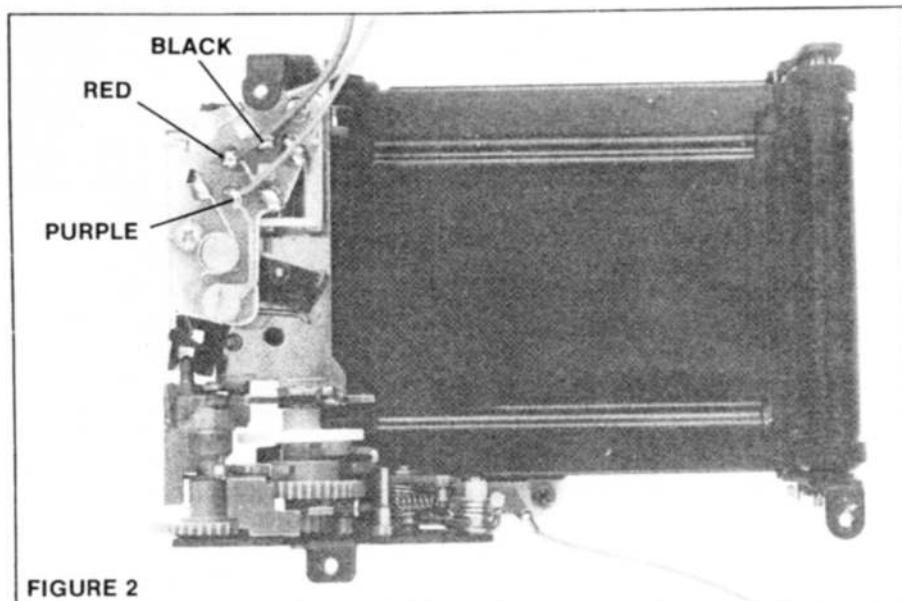
FIGURE 2

2. The shutter block has been revised, Fig. 2. Shutter blocks will interchange, but note the wiring to the shutter board.
3. The release magnet Mg2 has been revised. The new style doesn't have the post on the armature, Fig. 3. If you replace an old-style magnet with a new-style magnet, also replace the release-coupling arm (the arm that the release magnet engages to release the mirror); the new style has an upraised tab that connects to the new-style magnet, Fig. 3. New-style magnet — 2019-0850-11. New-style release-coupling arm — 2006-0527-02.

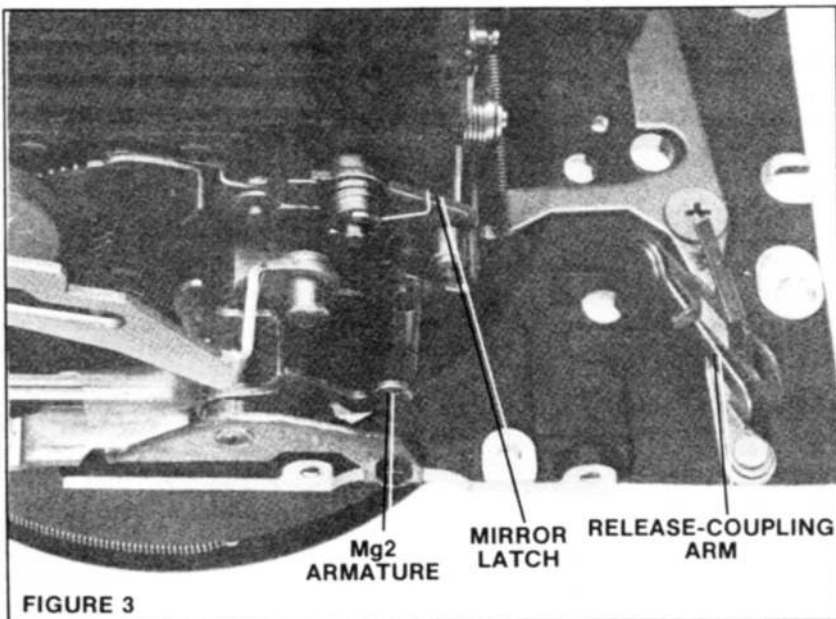
FIGURE 3

4. The mirror latch, Fig. 3, has a third revision. The old style (2006-0522-01) has a small post (2mm). The revised type has a larger post (2.5mm) because of the new-style brake system at the bottom of the shutter, Fig. 4. The latest revision (2006-0522-03) has a 3mm roller. You can use the latch with the roller in cameras that have the new-style brake system, Fig. 4. The revision corrects for mirror sticking

- (mirror hanging in aperture during exposure, especially evident at the slow speeds).
5. The take-up spool and shaft have been revised. The new-style shaft is plastic, and the take-up

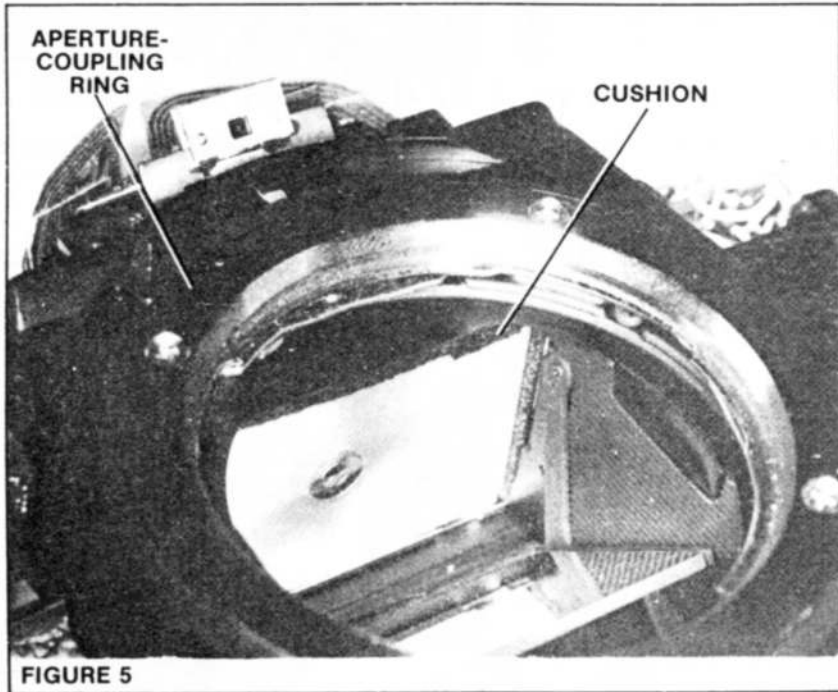
7. A cushion 2006-5114-81 has been added to the porous-plastic strip at the top of the mirror box, Fig. 5. The cushion corrects for mirror bounce (the mirror bouncing into the light path during the exposure). If the mirror cuts off the top of the frame at speeds of 1/30 and faster, cement the cushion to the top front of the mirror box as shown in Fig. 5.

8. The aperture-coupling ring, Fig. 5, has been improved. The new style has more flexible brushes. If all the LEDs flicker at the same time, the problem may be poor contact in the aperture (AV) resistor. But, if you bend the brushes to improve the contact, you may find that the aperture-coupling ring moves stiffly. You can then install the revised aperture-coupling ring 2006-0120-02.

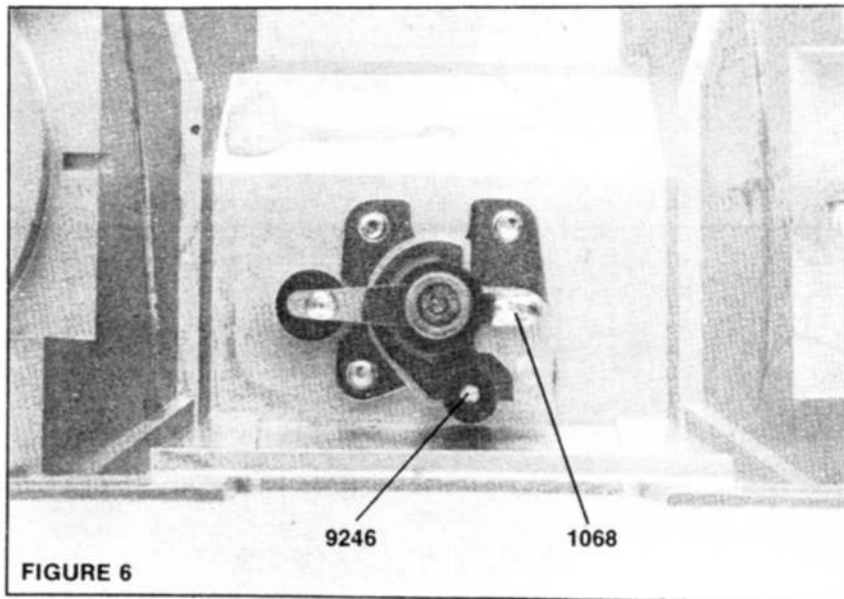
9. The problem of damage to IC1 by an off-brand flash has been practically eliminated by the revision to the hot-shoe contacts inside the top cover, Fig. 6. With the old style, sparking between the hot-shoe flash contact and the dedicated-flash pin could damage IC1. To correct, replace the dedicated-flash pin in the hot shoe with the longer revised pin

#9246. Just push out the old pin from the bottom of the hot shoe and press the longer pin into place from the top of the hot shoe. Also remove the pressure contacts from the photocell board (push out the rivets). Because of the longer dedicated-flash pin, wire directly to the top cover. Replace the hot-shoe flash contact with contact #1068; the new-style contact has a tab for direct soldering. If the camera has a black top cover, first take out the hot-shoe base, Fig. 6, and install ground contact 1338 under the base. Solder the green wire to the hot-shoe flash contact 1068. Solder the white

wire to the dedicated-flash pin 9246. For black-body cameras, solder the black ground wire to the ground contact 1338.
